Service Bulletin

Bulletin No.: 18-NA-246

Subject: Malfunction Indicator Lamp (MIL) Illuminated - DTC P0172, P06DE and/or P0521 Set (North America Vehicles Only)

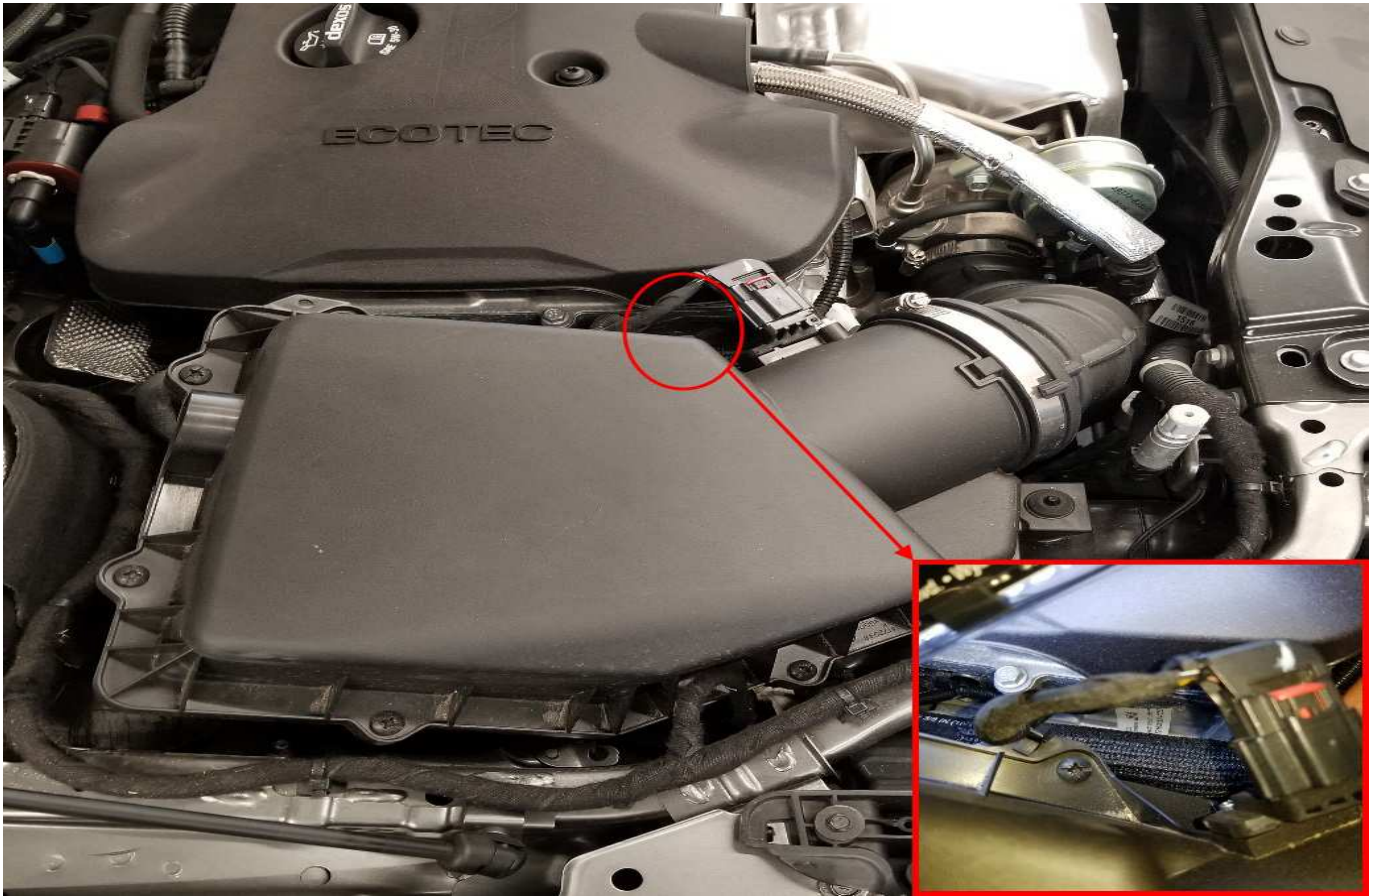
5336568

Vehicles built after May 7, 2019 may already have the updated PCV installed. Inspect the Engine Julian Date by reviewing the EUN on the front engine cover.

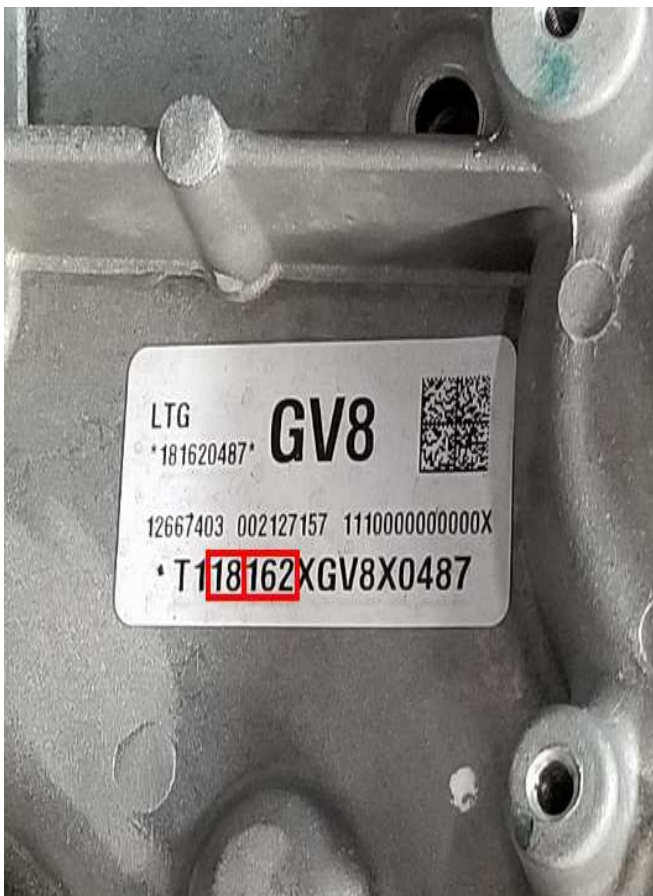
5336723

Example Engine Unit Number:

- The first digit reflects the engine plant (in this case T = Tonawanda).
- The second digit reflects the shift (in this case 1 = First Shift).
- The third and fourth digits reflect the calendar year (in this case 18 = 2018).
- The fifth, sixth and seventh digits reflect the day of that calendar year (in this case 162 = 162nd day of 2018 calendar year (build date)).

If the engine you are working on was built on or after Julian Date **19127** (May 7, 2019), EUN# **T119127** XHXTX0251, the PCV does not need to be replaced. The new revised PCV is already installed in the camshaft cover. Refer to SI for further diagnostics.

Engines built prior to Julian Date 19127 (May 7, 2019), EUN# **T119127** XHXTX0251, have the old style primary PCV valve installed and will need to be replaced. Continue with service procedure below.

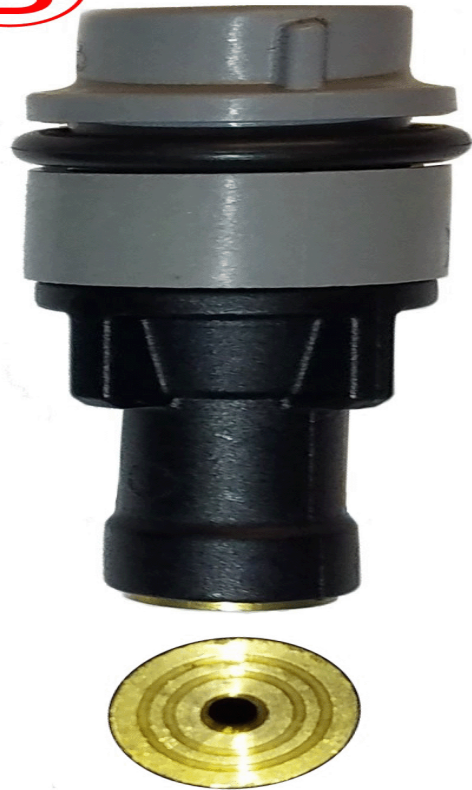
5207126

Note: The graphic above compares the old style primary PCV valve (A) to the **new** revised PCV valve (B).
