Release Date	03/22/2022	Technical Service Bulletin		
<b>97GG UPDATE</b>

<b>Securing Positive Battery Terminal – (NVLW)</b>

## Securing Positive Battery Terminal – (NVLW)

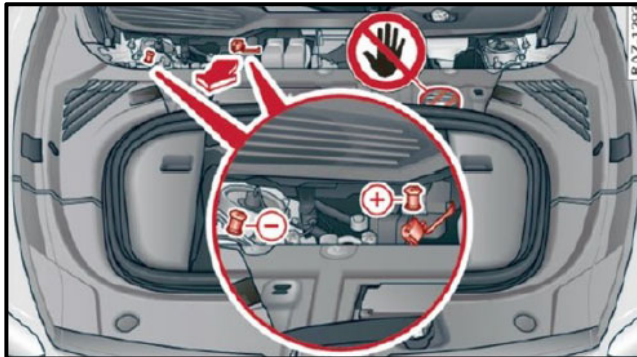
<b>This Update has been proactively released to prevent the following condition(s) from occurring in the vehicle:</b>	
Criteria	Technical Background
F8	On a small number of Audi e-tron GT vehicles manufactured within a specific period, the wiring harness for the positive terminal on the 12 Volt battery may not have been tightened to the specified torque due to a production irregularity.

- Tighten positive terminal to 20 Nm.
- Reinstall plenum chamber cover in reverse order of removal.
