Tech Tips

TT 72-08-02

2009-2013 Routan – Third Row Seating

December 13, 2013: Update to Information.

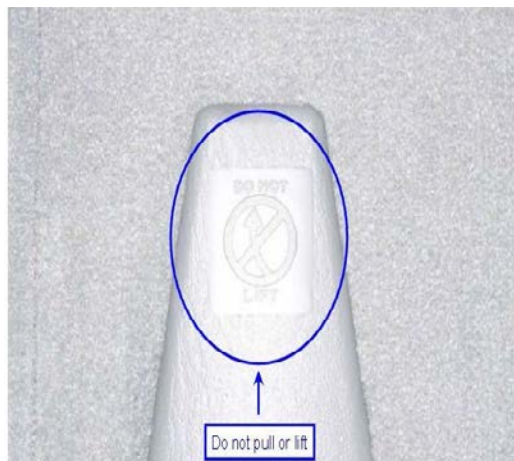
Figure 1

Pulling up on any of the third row seating legs is not recommended (Figure 1) as this may cause the leg(s) to not fold flat when the seat is in the stowed position (figure 2). If the third row seating leg(s) do not fold flat into the seat, the tension spring on the affected leg(s) will need to be replaced. Repair kit part numbers, for reference only, are as follows:

[7B0898305 Spring repair kit for folding seat leg \(manual folding seats\)](#)

[7B0898305A Spring repair kit for folding seat leg \(power folding seats\)](#)
