TECHNICAL SERVICE BULLETIN

Long Wheelbase - Second Row Seat(s) Stuck Or Difficult To Fold/Unfold - Built On Or After 1-Jan-2013

22-2114

23 March
2022

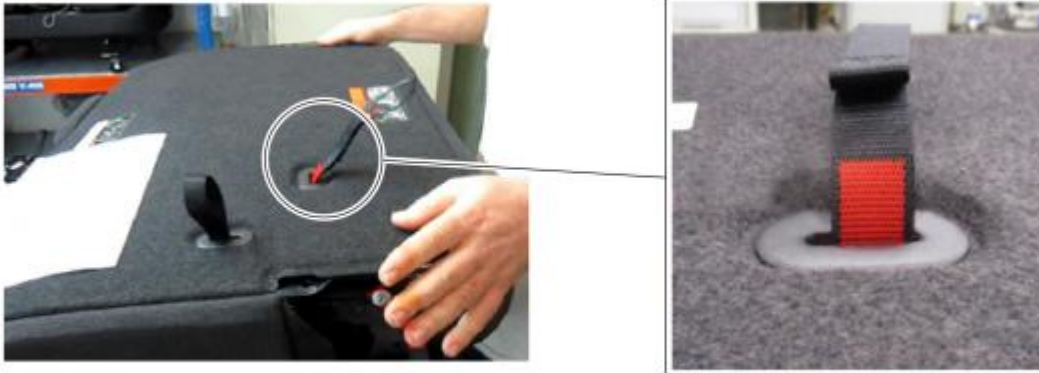
Figure 1

1. Is either section of the second row seat bottom stuck in the folded position and/or is the strap stuck and displaying the red indicator on the strap on the seat back? (Figure 1)

NOTE: The seat back will not fold when the seat bottom is stuck in the stowed position.
