94-22-01 - Taillights Cluster Condensation

Release date: 3/29/2022

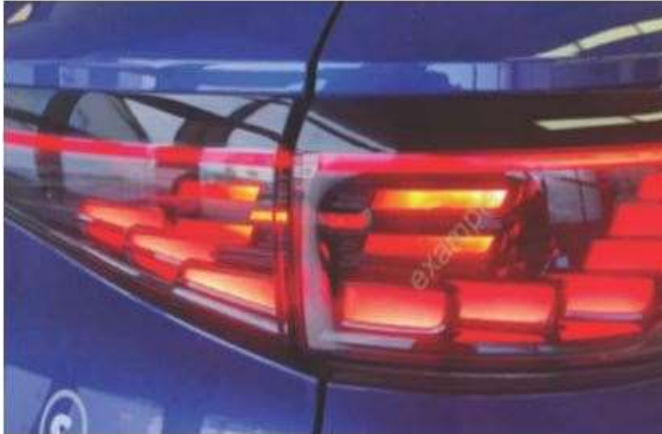
Figure 1:

1. Examples of taillights with slight condensation with no drips or water droplets.

1. Taillights: the condensation should systematically dry out after a change of the climate conditions.

This condition is normal, no replacement necessary.

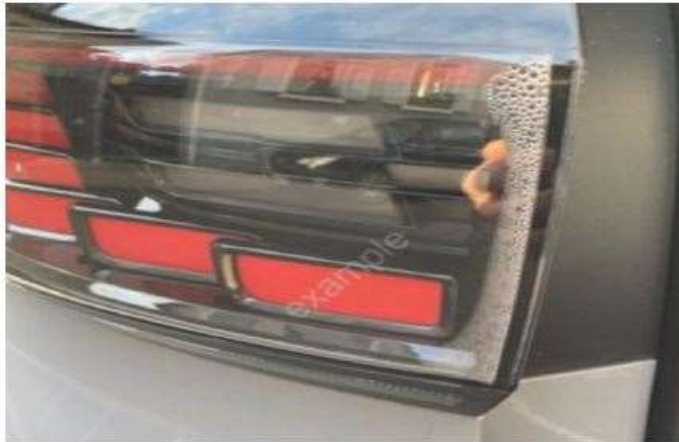
Figure 3:

2. Examples of taillight condensation, with droplets or water dripping.

2. In case of an obvious water ingress check the tail light cluster for optical faults (seal fit, taillight housing cracks).
