# Service Bulletin

Bulletin No.: 22-NA-007

**Subject: Poor Engine Performance in Extremely Cold Weather Conditions for LE2 Engines, Charge Air Cooler (CAC) Icing - Malfunction Indicator Lamp (MIL) Illuminated, DTC P0299, P0234, P0236, P2227, P00C7 Set**

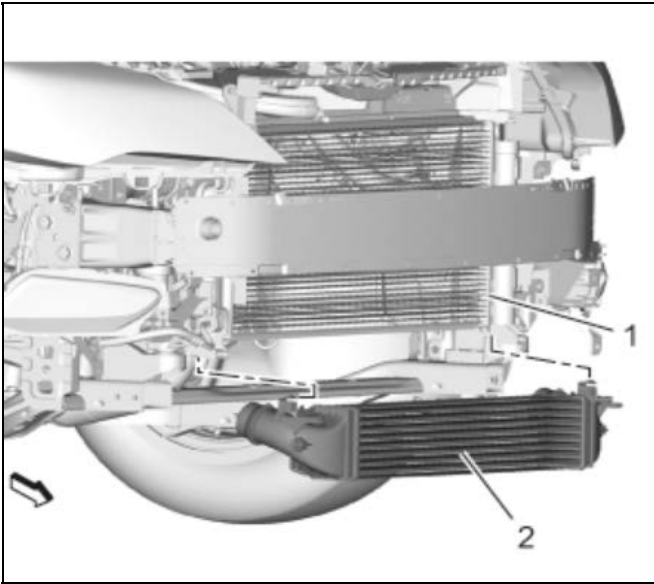
4171562

<b>Cause</b>	This condition may be caused by ice accumulation in the charge air cooler (CAC), restricting air flow to the throttle body.
<b>Correction</b>	<p>If any of the above conditions are present, allow time for possible ice build up in the CAC to melt by allowing the vehicle to thaw in a warm environment.</p> <p>If there is a check engine light with a P0234 or P0299 DTC during cold weather driving, refer to Turbocharger/Supercharger Boost Sensor Inspection below.</p> <ul style="list-style-type: none"> <li>– Frozen oil/water contaminant in the Turbocharger Wastegate Regulator Solenoid Valve (TCV) is often concurrent with vehicle operating conditions that cause CAC freezing. If either DTC P0234 or P0299 is set, refer to PIP5812C for Turbocharger Wastegate Regulator Solenoid Valve Inspection. Cleaning or replacing the TCV solenoid should be performed in addition to CAC protection measures specified in this bulletin.</li> </ul> <p>Follow the Service Procedure below once the vehicle has had time to thaw.</p>

1. Remove the CAC (2) and drain any moisture built up. Refer to *Charge Air Cooler Replacement* in SI.

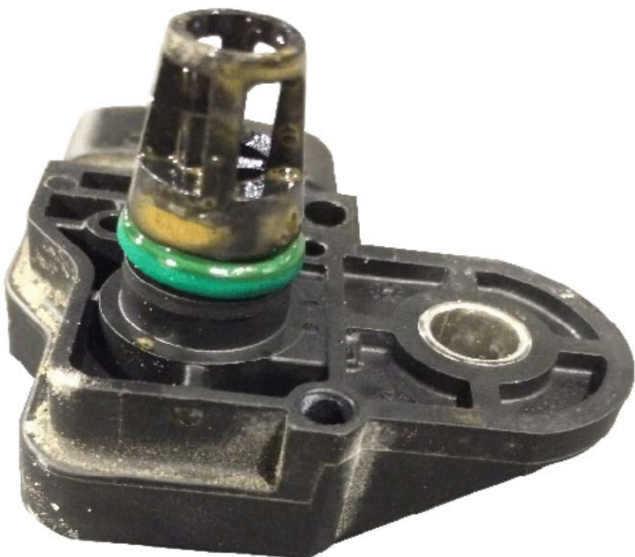
4910683

2. Inspect the sensor for any contaminants.

3. Allow time for any ice build-up to melt by placing the sensor port down.
4. Clean the sensor with a clean towel.
5. Install the sensor. Refer to *Turbocharger/Supercharger Boost Pressure Sensor Replacement* in SI.
