## Index of models

**NEW TOPICS** 3

### NEW TOPICS

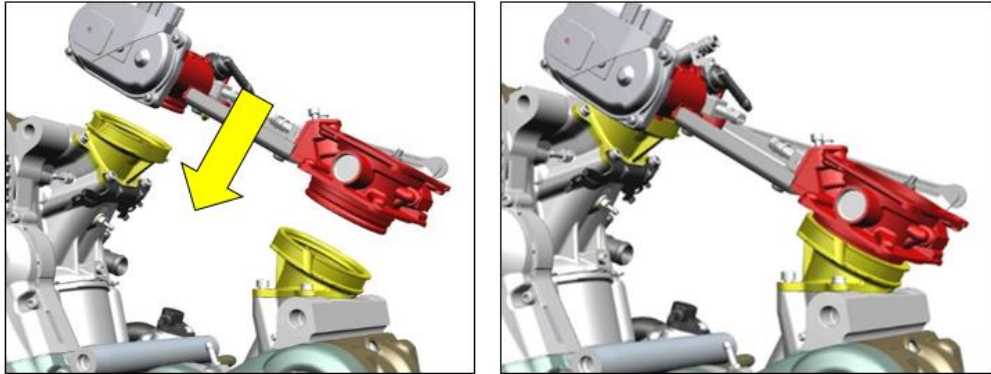
no.	Symptom	Subject	Photo	Notes and Indications - Corrective action
1	<p><u>ONLY</u> <u>Monster 821</u> <u>Monster 1200</u> <u>SuperSport</u></p> <p>Possible engine popping sound during deceleration and/or irregular idling</p>	Airbox

<p>We have received some complaints about a possible engine popping sound during deceleration. The performed analyses have shown that this symptom could be caused by an incorrect installation of the throttle bodies in the relevant intake manifolds (possible deformation of the rubber profile).</p> <p>Therefore, if you find any similar symptoms, we kindly ask you to check the correct installation of the Airbox on the motorcycle and in particular that:</p> <ul style="list-style-type: none"><li>- throttle bodies are correctly inserted inside rubber intake manifolds, along the whole perimeter;</li><li>- the rubber profile of the intake manifolds is not deformed.</li><li>- the 2 fastening ties are correctly positioned in the seat on the intake manifolds</li></ul> <p><b>Please be reminded that, in order to make throttle body insertion easier on rubber intake manifolds, the use of silicone lubricant or similar product is absolutely necessary.</b></p> <div data-bbox="1137 675 2125 1050">

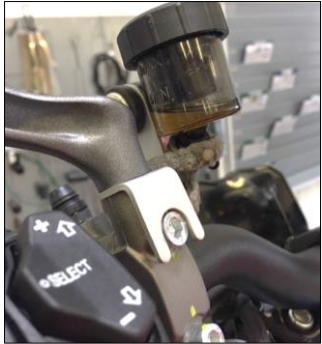
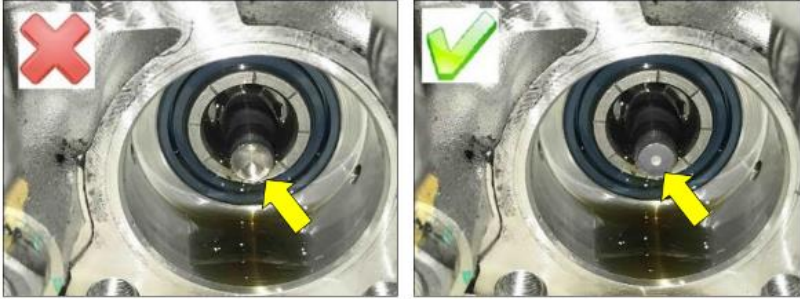
no.	Symptom	Subject	Photo	Notes and Indications - Corrective action
6	<p><u>ONLY</u> <u>models equipped with</u> <u>hydraulically controlled</u> <u>clutch lever</u></p> <p>Possible reduction of the clutch fluid level inside its reservoir</p>	Hydraulic clutch control

<p>We received a few claims concerning a reduction of the clutch fluid level inside its reservoir. We would like to inform you that it is not sufficient to carry out the bleeding procedure or top up the clutch fluid inside the reservoir. We suggest, at a preliminary stage, to check:</p> <ul style="list-style-type: none"><li>• the play between the clutch master cylinder and the lever</li><li>• if the clutch pushrod is worn or damaged in the area of contact with the clutch slave cylinder (ball)</li><li>• the condition of the clutch slave cylinder protective diaphragm, which must not be torn.</li></ul> <p>According to our analyses, this phenomenon is due to a DOT4 leakage from the primary seal of the clutch slave cylinder (missing fluid in the reservoir builds up in-between the clutch slave cylinder diaphragms); in some cases, this phenomenon is also accompanied by wear of the clutch pushrod. We therefore ask you to replace the slave cylinder with a new <b>part no. 19540091D</b> featuring a new gasket in order to prevent the phenomenon described above.</p> <p>If the clutch pushrod is damaged as shown in the figure, replace it as well.</p> <div data-bbox="1227 719 2024 1018">

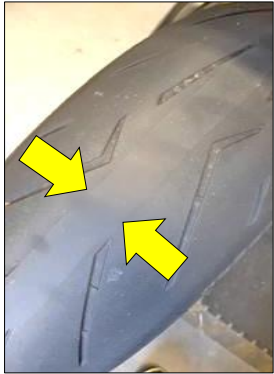
8	<p>Possible formation of a well-marked "band" in correspondence with the central area of the Pirelli Diablo Rosso Corsa II rear tire</p>	<p>Pirelli Diablo Rosso Corsa II rear tire</p>

<p>We have received some isolated reports of the appearance of a "band" in correspondence with the central area of the Pirelli Diablo Rosso Corsa II rear tire.</p> <p>We would like to inform you that, since these are extremely sporty tires with 5 different compound zones at the rear, it can happen that, depending on the type of use of the motorcycle, they wear out in a different way causing the above mentioned phenomenon to occur; sometimes this occurs on the shoulder area, sometimes in the central area but, in general, it is a purely aesthetic phenomenon that does not affect the performance of the tire itself.</p>

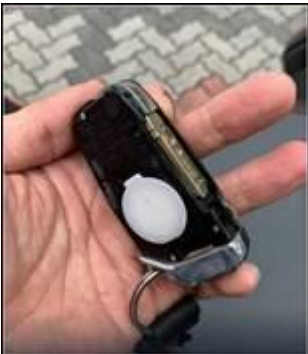
<p>We have received some isolated reports about the possible loss of the rear cover of the active key Part no. 59810361F. Analyses have shown that this phenomenon occurs after repeated opening/closing of the cover itself, resulting in the deterioration of the shell.</p> <p>We would like to inform you that the new rear cover <b>Part no. 4601L831A</b>, avoiding the phenomenon described above, is now available.</p>

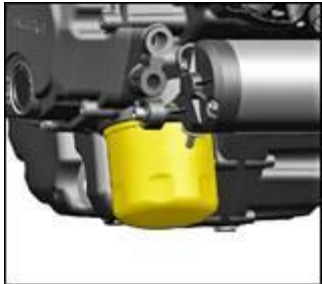
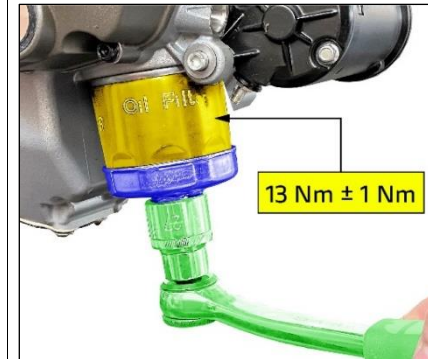
<p>Please, be informed that following changes concerning the engine oil filter cartridge, the tightening torque has been increased from 11 Nm to <b><u>13 Nm ± 1 Nm</u></b>.</p> <p>Please be reminded to lubricate the oil filter cartridge seal with engine oil and to use a commercial tool for tightening, as shown in the figure.</p>

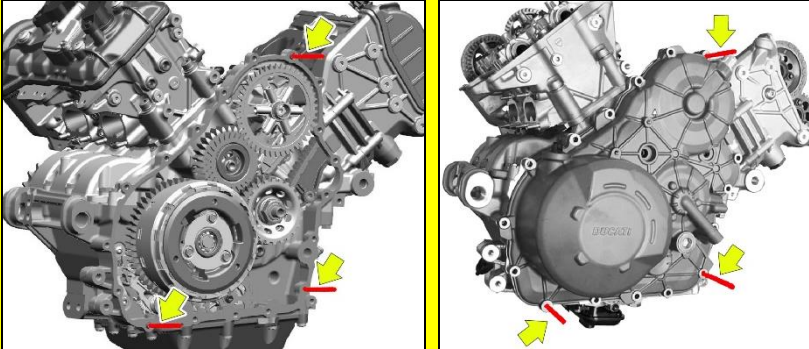
no.	Symptom	Subject	Photo	Notes and Indications - Corrective action
21	<p><b>NEW</b></p> <p><u>ONLY</u> <b>Desmosedici Stradale V4</b> <b>ENGINES</b></p> <p>Possible damage to water pump gear oil seal</p>	Water Pump Gear Oil Seal

<p>We have received some reports of a pronounced blow-by effect that may cause small amounts of oil to leak from the clutch cover. This effect could be caused by excessive wear of the water pump gear oil seal on the clutch cover.</p> <p>If this problem is found, we suggest that you check the condition of the oil seal inside the clutch cover and replace it if necessary. When replacing it, remember to lubricate the oil seal with KLÜBERPLUS S 06/100 lubricant (or equivalent) and reposition it correctly using tool part no. <b>887138858</b>.</p> <p><u>Warning:</u> During refitting, for correct positioning of the clutch cover, it is necessary to use 3 centering pins <b>part no. 887132933</b>, positioned as shown in the figure, to avoid possible damage to the water pump gear oil seal.</p>

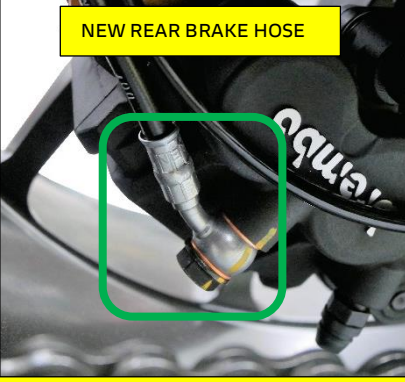
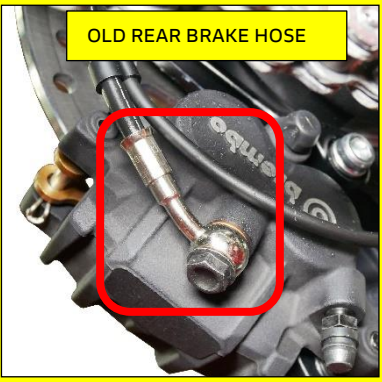
no.	Symptom	Subject	Photo	Notes and Indications - Corrective action												
2 <span style="color: red; font-weight: bold; font-size: small;">NEW</span>	<p style="text-align: center;"><b>ONLY</b> <b>Diavel 1260</b></p> <p>Indication for replacement of brake hoses under warranty</p>	Rear Brake Hose	-	<p>We remind you that from the dates below the DIAVEL 1260 model is equipped with the new brake hoses.</p> <p>In the event that you have to manage a Customer complaint related to a rear brake system, always check the rear brake hoses installed on the vehicle.</p> <p>If the bike is already equipped with the modified hoses (FrenTubo), the warranty claim will be NOT accepted or will be charged back.</p>

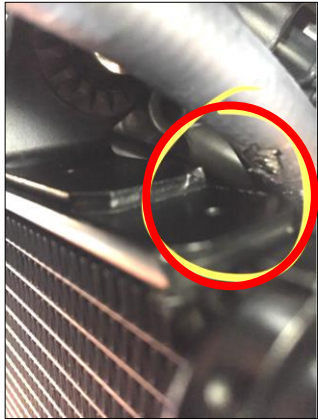
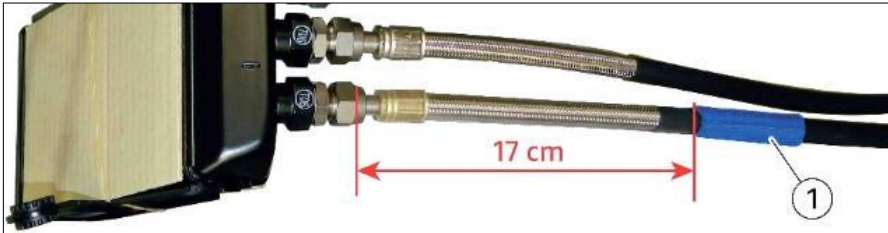
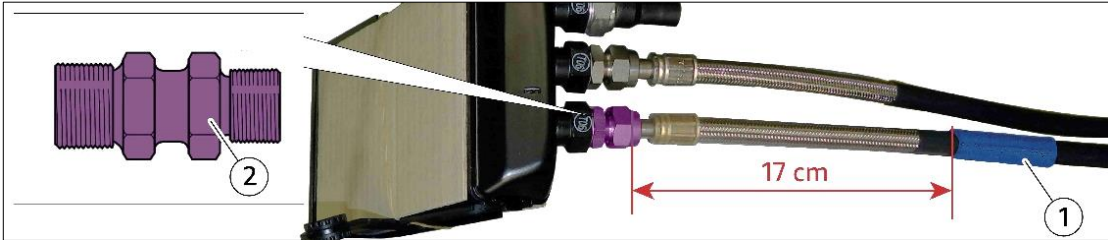
no.	Symptom	Subject	Photo	Notes and Indications - Corrective action
3	<p><u>ONLY</u>  <b>Multistrada 950 MY 17-20</b>  <b>Multistrada 1200 MY 15-17</b>  <b>Multistrada 1260 MY18-20</b>  <b>(all model versions)</b></p> <p>Possible superficial damage to the oil cooler return pipe</p>	Oil cooler pipes

<p>We have received some isolated reports of possible surface damage to the oil cooler return pipe due to rubbing with the top of the coolant radiator, over time. <u>This phenomenon is purely aesthetic and does not affect the correct operation of the system.</u> We inform you that for the models:</p> <p><b>a) Multistrada 1260:</b>  starting from the frame number ZDMAC03AAAKB011354 (on 27/05/2019) the <b>anti-abrasion sheath (1) part no. 4601H701A</b> has been introduced on the oil cooler return pipe, positioned at a distance of <b>17 cm</b> measured from the upper end of the fitting. (This solution is also applicable to all Multistrada 1200 versions Model Year 2015-2017).</p>

<p><b>b) Multistrada 950:</b></p> <ul style="list-style-type: none"> <li>- starting from the frame number ZDMAD00AAKB002259 (on 10/05/2019) the <b>anti-abrasion sheath (1) part no. 4601H701A</b> has been introduced on the oil cooler return pipe, positioned at a distance of <b>17 cm</b> measured from the upper end of the fitting;</li> <li>- starting from the frame number ZDMAD00AALB005691 (on 12/03/2020) the longer <b>fitting (2) part no. 81510391A</b> has been introduced at the oil return pipe outlet from the cooler.</li> </ul>

<p>We ask you to always check the condition of the oil cooler return pipe, and to replace it <b>ONLY</b> if the rubber sheath is damaged and the metallic braided hose can be seen. Follow the assembly notes indicated above according to the reference model. The spare part catalogue has been updated.</p>

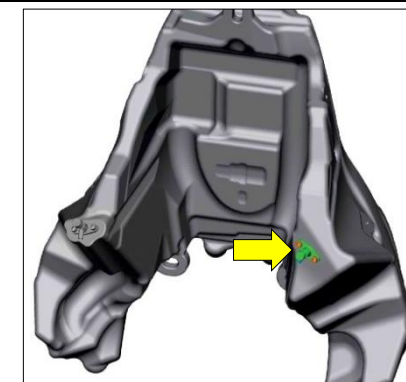
18	<p><b>ONLY</b> <b><u>Multistrada V4</u></b> <b><u>(all model versions)</u></b></p> <p>Incorrect residual fuel in the tank</p>	Fuel tank	-	<p>In some cases, we have found that the tap on the right-hand side of the fuel tank is completely closed instead of open; this leads to an incorrect remaining range when there are only a few liters of fuel in the tank (fuel reserve conditions).</p> <p>If the above-mentioned event occurs, we ask you to ensure that the tap on the right-hand side of the fuel tank is fully open</p>

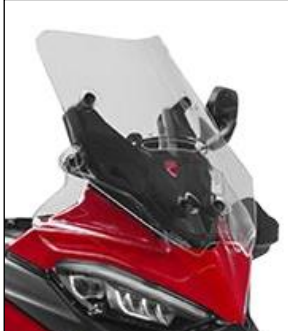
<p>We have received some reports about a possible oxidization of the windscreen retaining screws. Analysis has shown that this phenomenon could be caused by an unsuitable technological process that causes oxidation in the groove of the flat and in the holes made for decreasing part weight.</p> <p>Should you find such a phenomenon, please replace the 4 windscreen screws (<b>Part no. 7791C301AB</b>) and tighten them to <u>3 Nm ± 10%</u>.</p>

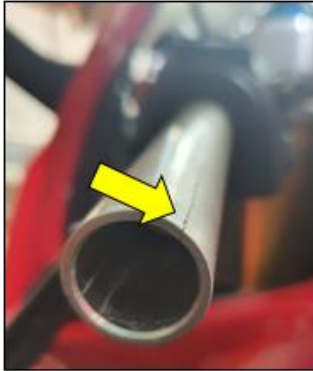
<p>We received some isolated claims about the possible triggering of a longitudinal crack on the handlebar, on balancing weight side. Our laboratory analyses found that said crack is due to an excessive tightening torque applied when installing the balancing weights.</p> <p>When installing balancing weights on the handlebar, please comply with the tightening torque specified for the M6x55 screw to <b>8 Nm ± 10%</b>, as indicated on the bulletin introducing the model and on the Workshop Manual.</p>

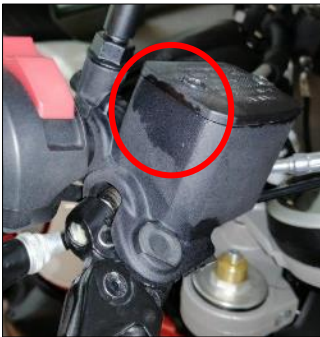
<p>We inform you that in case of complaints from Customers about a possible oozing out of front brake fluid from the relevant reservoir. This condition does not affect the operation of the brake system. It is possible to order the following kit part no. 89340331A as spare part to avoid the symptom in question.</p> <p>The kit part no. 89340331A includes:</p> <ul style="list-style-type: none"> <li>• 2 screws (1)</li> <li>• Cover (2)</li> <li>• Membrane (3)</li> <li>• Baffle (3)</li> </ul>

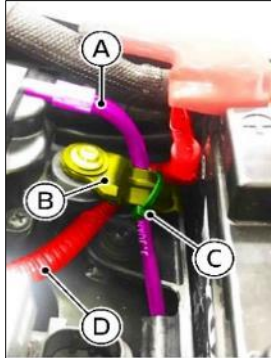
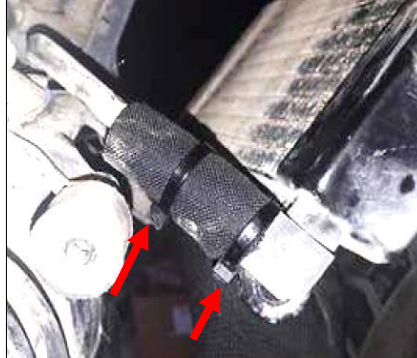
5	<p><u>ONLY</u> <b>Scrambler 1100 PRO</b> <b>(all versions)</b></p> <p>Irregular operation at idle speed and engine power loss</p>	Vertical cylinder LH spark plug cable	-	<p>As a result of continuous quality tests on the product, we have found a possible irregular operation at idle speed and engine power loss. This phenomenon is due to a settling of the vertical cylinder LH spark plug cable on the coil caused by the contact with the fitting of the oil return pipe from cooler (visible on motorcycle RH side). The MIL light does not come on.</p> <p>We ask you to always check the conditions of vertical cylinder LH spark plug cable and to apply the protective sheath Part no. 4601C581A (cut in half and secured in place with two small self-locking ties) on the fitting of the oil return pipe from cooler to avoid the above-described phenomenon.</p>

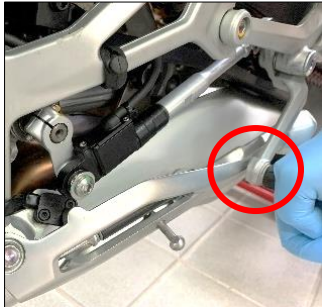
<p>As a result of continuous quality tests on the product, we have found a slight interference between the gear shift control lever and the side stand. This contact is very slight, does not give rise to functional or aesthetic problems and can only occur in the overtravel phase, when engaging the first gear.</p> <p>We inform you that no corrective actions are available so far.</p>
3	Assembly precautions for the complete titanium exhaust system part no. 96481652AA	Complete titanium exhaust system part no. 96481652AA

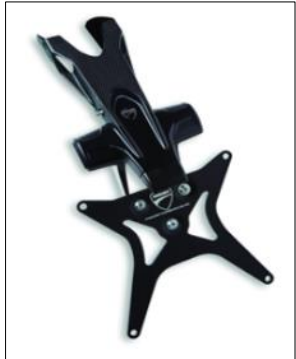
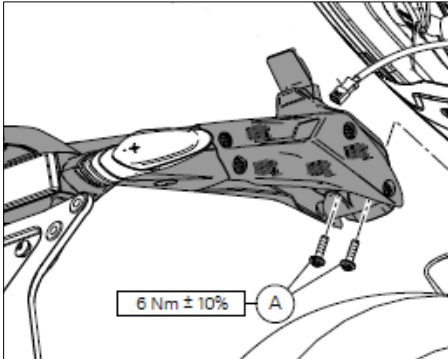
<p>When assembling the Ducati Performance carbon number plate holder unit part no. 97381161CA, we remind you to always apply <b>LOCTITE 243</b> on the threads of the <b>2 screws (A)</b> for fixing the unit to the rear subframe and tighten them to the specified torque of <b>6 Nm ± 10%</b> as indicated in the relevant instructions.</p>
