Volvo Chassis - Cab Roof Leak Repair , Technical Service Bulletin V-812-002, Cab Roof Leak Repair - VN Models 740 And 760 ONLY, Model Year 2018 And Newer

Cab Roof Leak Repair

V-812-002

Volvo VN and VT trucks

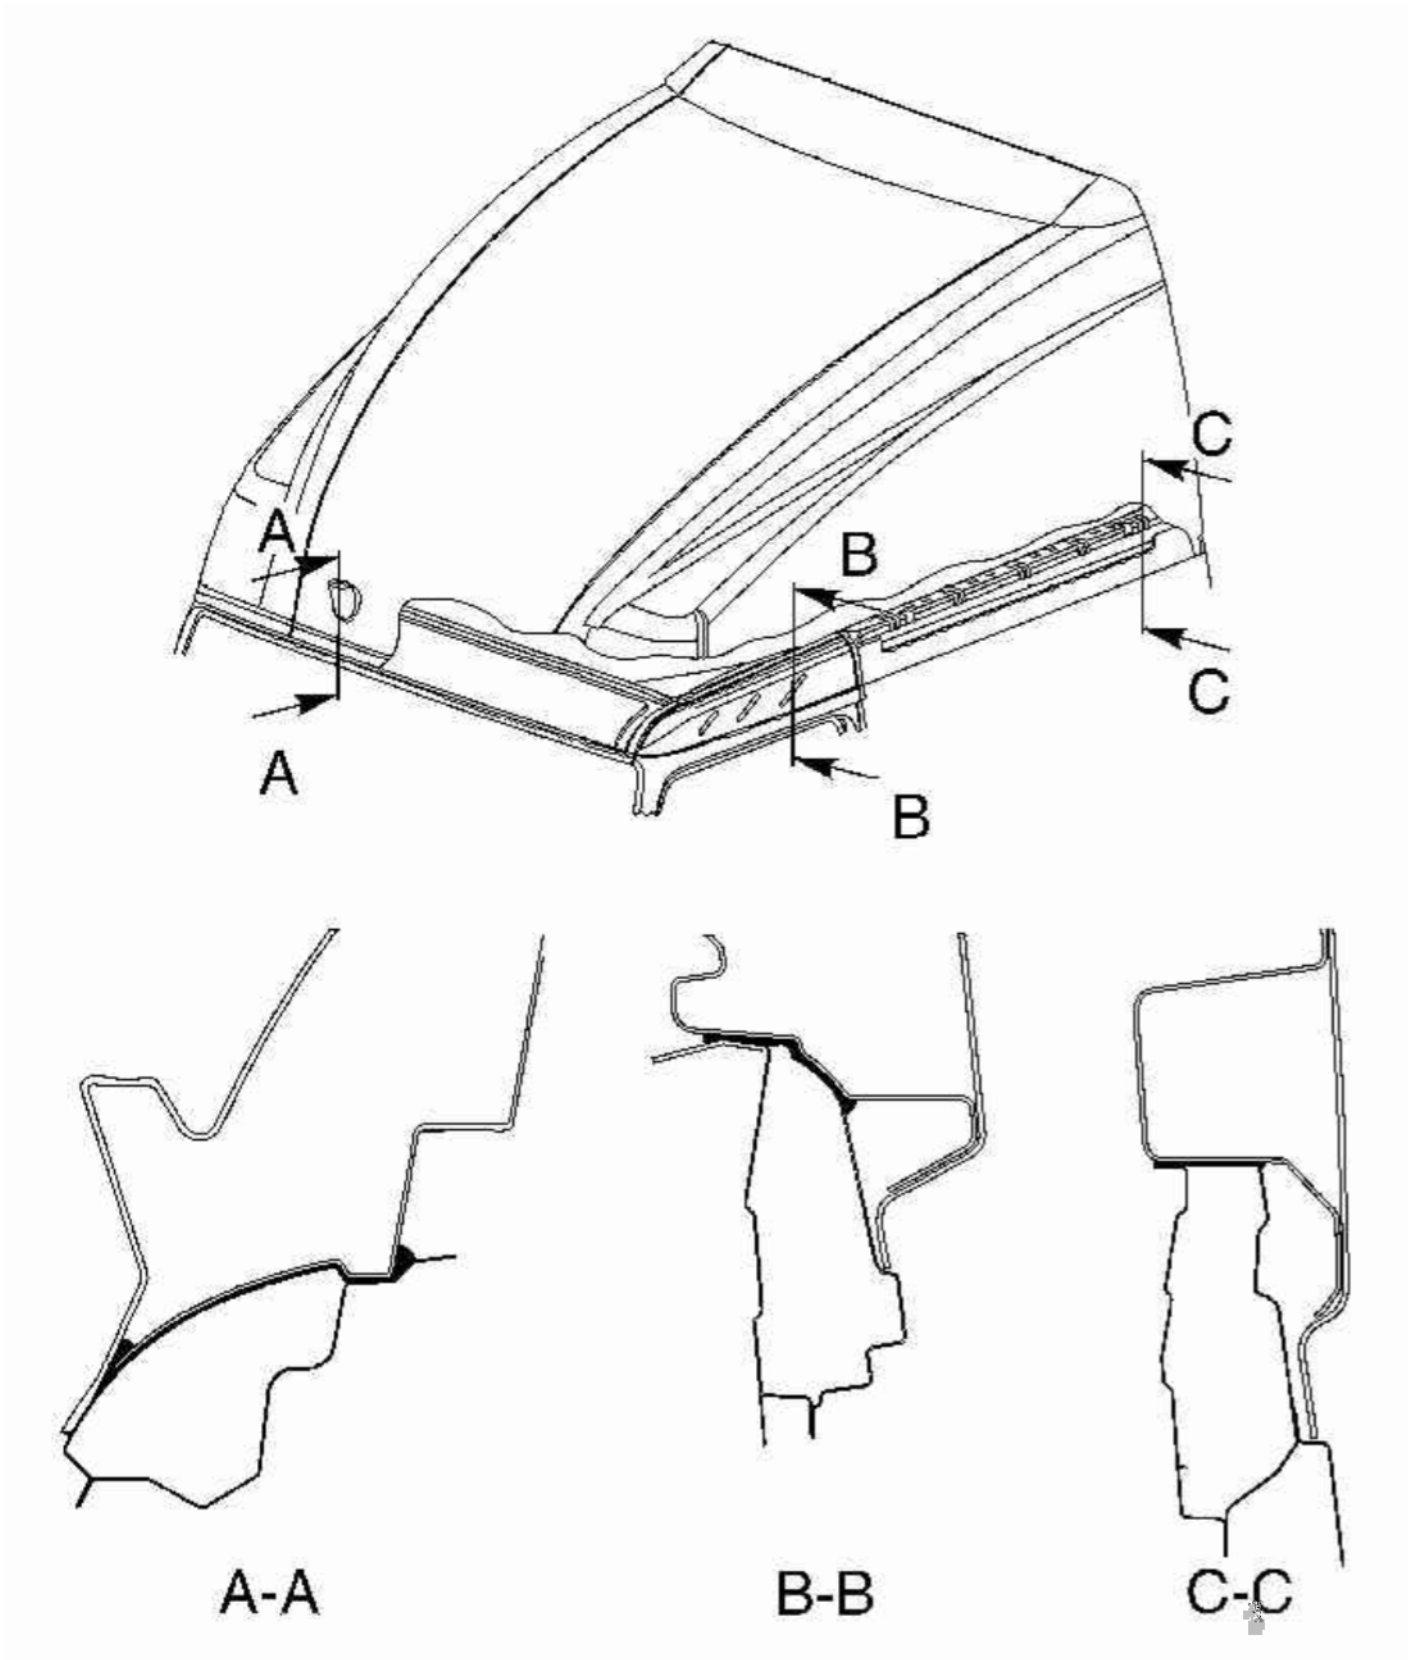
Cab Roof Adhesive Application Diagram

2. Apply the parking brake.
3. When the roof is installed at the factory the adhesive bonding areas are located at the upper edge on the cab structure not the lower edge of the roof, this leaves a void areas (see section drawings in Fig. 1) along both sides of the cab but not in the front or rear. When bonding the lower edge of the roof to the cab with FUSOR do not attempt to completely fill the void areas along the sides.
