Volvo Chassis - Diagnostic Trouble Codes (DTC's) - MID130 PID160 FMI1 Or FMI2 - For The I-Shift **Transmission**

I-Shift Transmission With Mixed Components

V-431-001A

(November 2010)

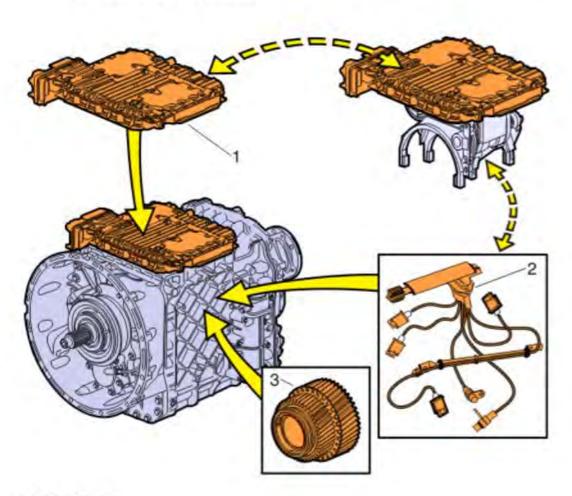
As of June, 2009 the new generation I-Shift transmission (Generation D) was released for production. There are three parts used in combination with the generation D (New) or C (Old) versions of the I-Shift transmissions (see figure below).

1. Transmission Electronic Control Unit (TECU).

TECU-D (New generation) or TECU-C (Old generation)

2. Cable harness including speed sensor.

Speed-sensor-D (New generation) or Speed-sensor-C (Old generation)

3. Sensor wheel.

72 tooth (New Generation) or 30 tooth (Old Generation)

Note: The difference between the new generation Gear Control Unit (GCU-D) assembly and the old generation Gear Control Unit (GCU-C) assembly is the TECU-D (1) and the new speed-sensor-D (2). The rest of the GCU is equivalent to the old generation.

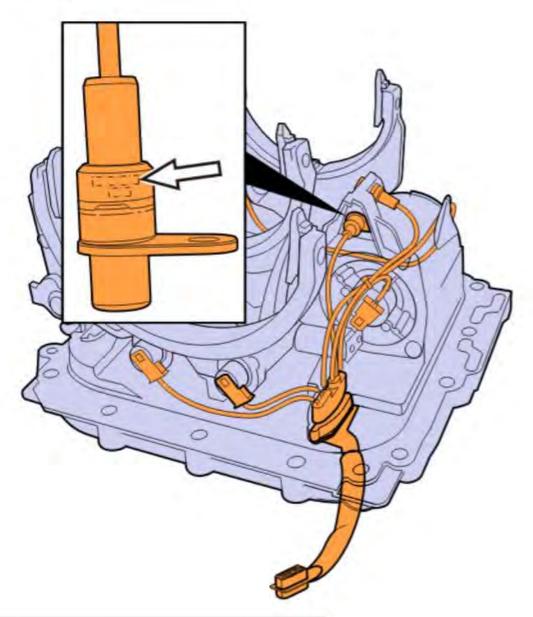
The new cable harness includes a new speed-sensor. The cable harnesses are not marked with different part numbers. To identify the speed sensor generation, look at the number stamped on the sensor.

Note: To identify speed sensor with cable harness, see graphic below for details.

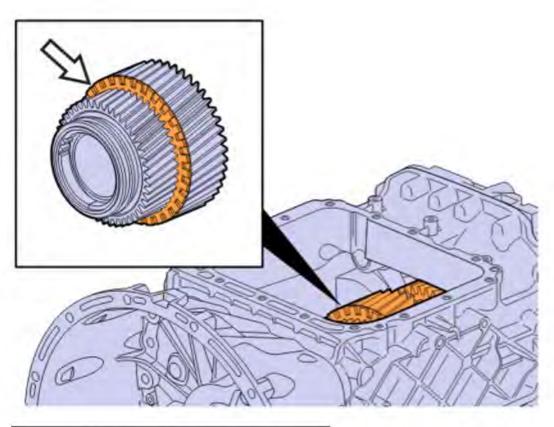
Sensor Wheel

For the main shaft there is a new sensor wheel which has 72 tooth compared to the old version which had 30 tooth. The 72 tooth sensor wheel is installed in the I-Shift generation D transmissions and I-Shift generation C transmissions built beginning June, 2009. There will be 72 tooth sensor wheels installed in I-shift generation-C Reman units where a complete GCU-D was installed at remanufacturing.
