Complaint: Insects in the Tail Light - Replace Tail Lights if Necessary and Rework Them (142/21)

Model Line: **Macan (95B)**

Model Year: **As of 2019**

Concerns: **Side tail lights, left and right**

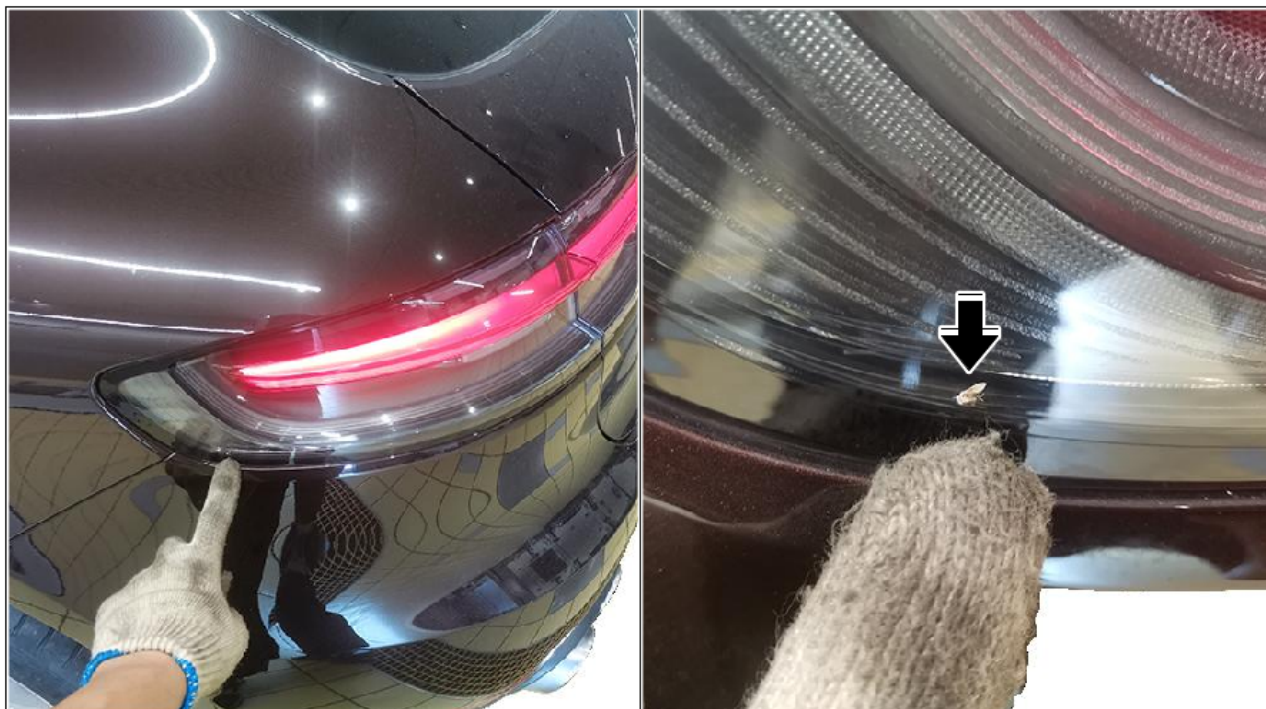
Information: Due to the concept-related internal fogging behavior, insects can enter the inner tail light via corresponding openings in the body and tail light.

Insect ingress for tail light

Action required: In the event of a customer complaint, replace the affected tail light and seal the opening for the cable bushing with a plastic foam strip.
