Oil Leak on Front-Axle Final Drive (194/21)

Vehicle Type: **Panamera 4 (971)/Panamera 4S (971)/Panamera Turbo (971)/Panamera Turbo S (971)/Panamera GTS (971)**

Model Year: **As of 2017**

Concerns: **Oil leaks around the front-axle drive**

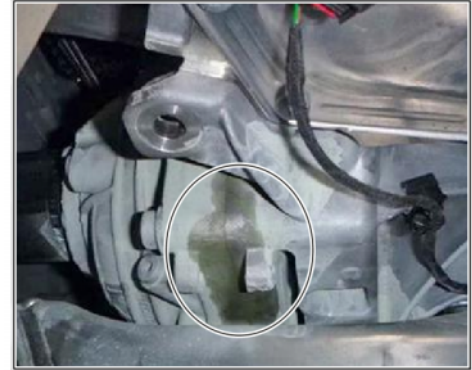
In most cases, if the complaint "Oil leak on front-axle final drive" is received, this can cause oil to leak from another leakage point.

Oil migration from the oil-filter housing area or oil that is next to it can occur, for example.

Example of oil residues on front-axle drive

Action required: In the event of a complaint, clean the front-axle final drive or the affected area thoroughly and spray leak-locating spray or powder on it. Then carry out a test drive and correct the identified leak as described in the Workshop Manual.

- 7 Take photos of the leak points found for PCSS.
⇒ *Example of oil residues on front-axle drive*
- 8 Correct identified leaks as described in the Workshop Manual.
