Service Bulletin

Bulletin No.: 20-NA-209

Subject: Service 4WD Message Illuminated on Driver Information Center (DIC), DTCs C118D, C119B and/or C119C Set

Brand:	Model:	Model Year:		VIN:		Engine:	Transmission:
		from	to	from	to		
Chevrolet	Silverado 2500HD/3500HD	2019	2022			All	All
GMC	Sierra 2500HD/3500HD	2019	2022

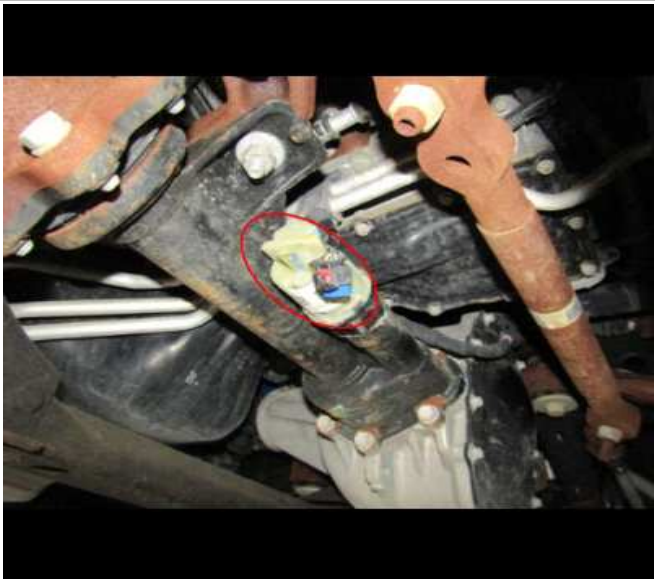
Involved Region or Country	North America, Israel, Saudi Arabia, Chile, Australia, New Zealand
Additional Options (RPOs)	
Condition	Some customers may comment on seeing a Service 4WD message illuminated in the DIC, Technicians may find DTCs C118D, C119B and/or C119C Set.
Cause	The cause of the condition may be water intrusion and corrosion within the front differential actuator connector and the electrical harness connector terminals.
Correction

<p style="text-align: right;">5660054</p> <p>Scan for DTCs and verify if C118D, C119B, and / or C119C are present. If any of the listed DTCs are present, inspect the front drive axle actuator electrical connector for signs of moisture, corrosion at the pins, or damage to the actuator housing.</p> <p>Note: Examples of damage to the actuator housing and the harness connector seal, are shown at the start of the Service Procedure below.</p> <p>Also inspect the electrical wire harness connector for any damage to the internal seal or signs of moisture and corrosion. If any of the listed conditions such as moisture, corrosion, or damage are present on either component, replace BOTH the front drive axle actuator and the electrical wiring harness that connects to the actuator.</p>

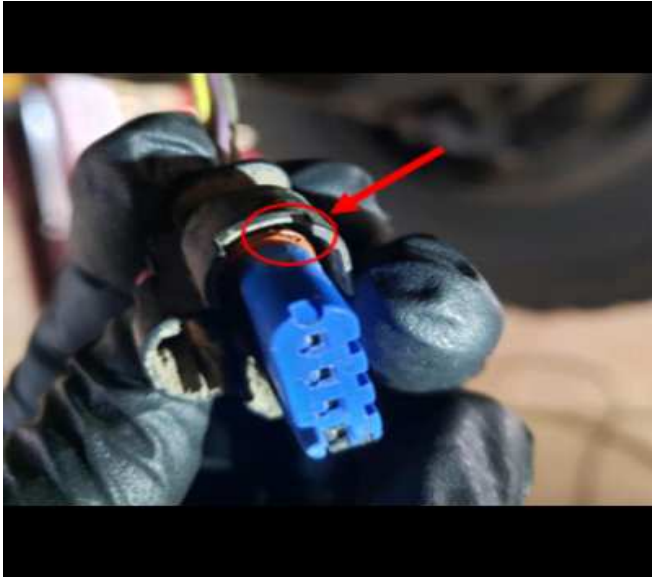
6017551

Electrical Harness Connector Seal Damage

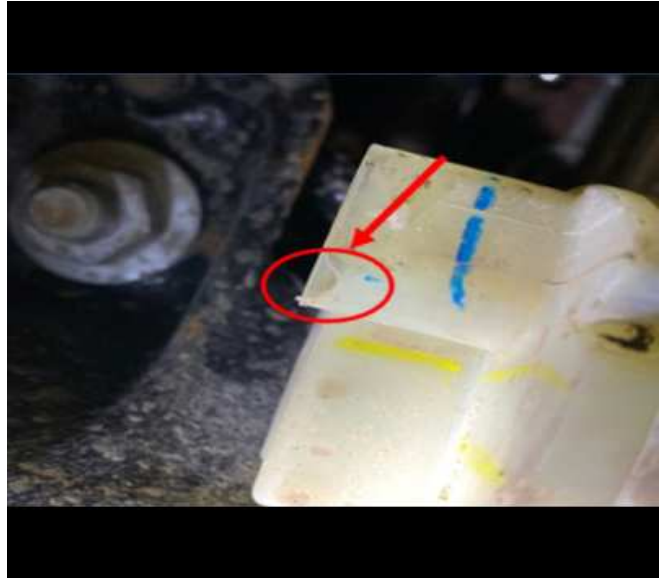
6017555

Front Drive Axle Actuator Housing Damage
