RCA-38-22-001-1: Front Drive Unit HV Cable Bracket Inspection and Replacement

Document Type	Customer Satisfaction Campaign Bulletin
Date	March 14, 2022
Affected Region(s)	USA
Affected Model(s)	R1T
Model Year(s)	2022
Approximate Build Dates Refer to the FSA Dashboard to determine if this document applies to a specific vehicle.	August 2021 - October 2021
Vehicle System	38 - Front Drive Unit
Minimum Service Location	Service Center

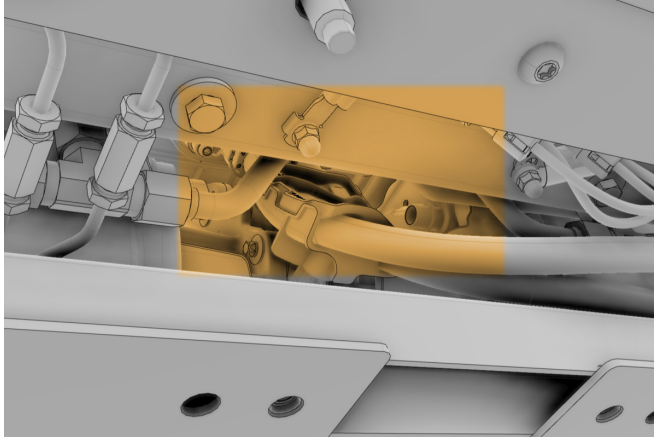
1. Remove: Panel, Underbody, Front Subframe (refer to service manual procedure 606515010).
2. Inspect the clearance between the frame and front drive unit HV cables:

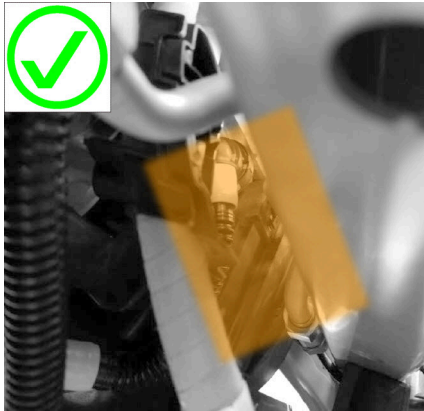
- If the clearance is approximately 1 inch (2.5 cm) or more, the correct bracket is already installed. No additional work is required. Reinstall all components that were removed for access and replace all non-reusable components.

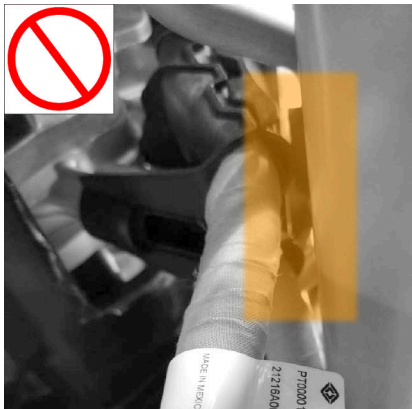
- If the clearance is less than less than 1 inch (2.5 cm), the incorrect bracket is installed. Continue to the [Front Drive Unit HV Cable Bracket Replacement](#) section.
