# RCA-78-22-004-1: Edge Clip on Body Harness Not Fully Seated

<b>Document Type</b>	Customer Satisfaction Campaign Bulletin
<b>Date</b>	March 24, 2022
<b>Affected Region(s)</b>	USA
<b>Affected Model(s)</b>	R1T
<b>Model Year(s)</b>	2022
<b>Approximate Build Dates</b>	August 2021 - December 2021
Refer to the FSA Dashboard to determine if this document applies to a specific vehicle.	
<b>Vehicle System</b>	78 - Low Voltage Electrical
<b>Minimum Service Location</b>	Mobile

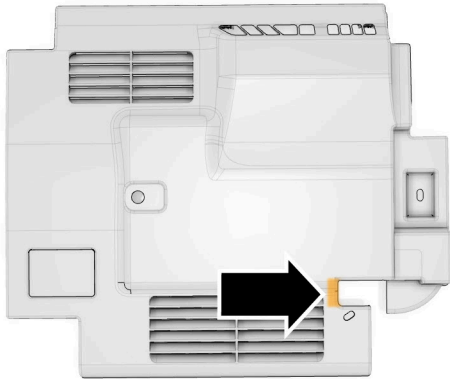
3. Underneath the RH front seat: Inspect the highlighted area for an edge clip that secures the RH side body harness.

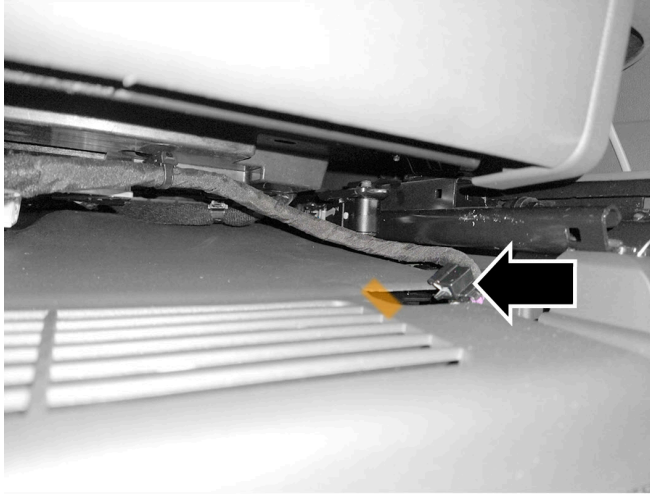
- If the edge clip is loose, inspect the harness for evidence of damage.

- If the harness shows evidence of damage: Escalate for diagnostic assistance.
- If the harness does not show evidence of damage: Fully seat the edge clip.
- If there is a gap between the edge clip and the vent, fully seat the edge clip.

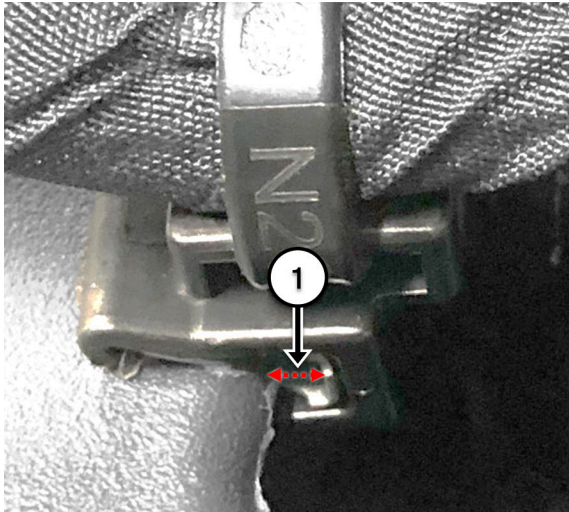
1 Gap between edge clip and vent

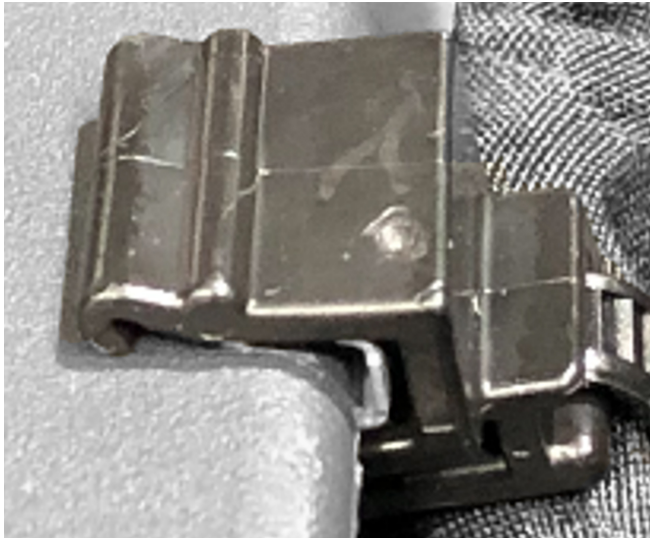
- If the edge clip is fully seated: No additional work is required.
