Technical product information

Topic	Odour emanating from the front wheel arches/front wheels - Odour is also evident within the cabin
Market area	Russische Föderation (5RU),Australia E04 Bentley rest Asia and Australia (6E04),China 796 VW Import Comp. Ltd (Vico), Beijing (6796),Germany E02 Bentley rest Europe (6E02),Japan E03 Bentley Japan (6E03),Korea, (South) E08 Bentley South Korea (6E08),United Arab Emirates E06 Bentley Middle East and Africa (6E06),United Kingdom E01 Bentley UK (6E01),United States E05 Bentley USA and rest America (6E05)
Brand	Bentley
Transaction No.	2066580/1
Level	EH
Status	Approval
Release date

New Continental GT/GTC, New Flying Spur and Bentayga

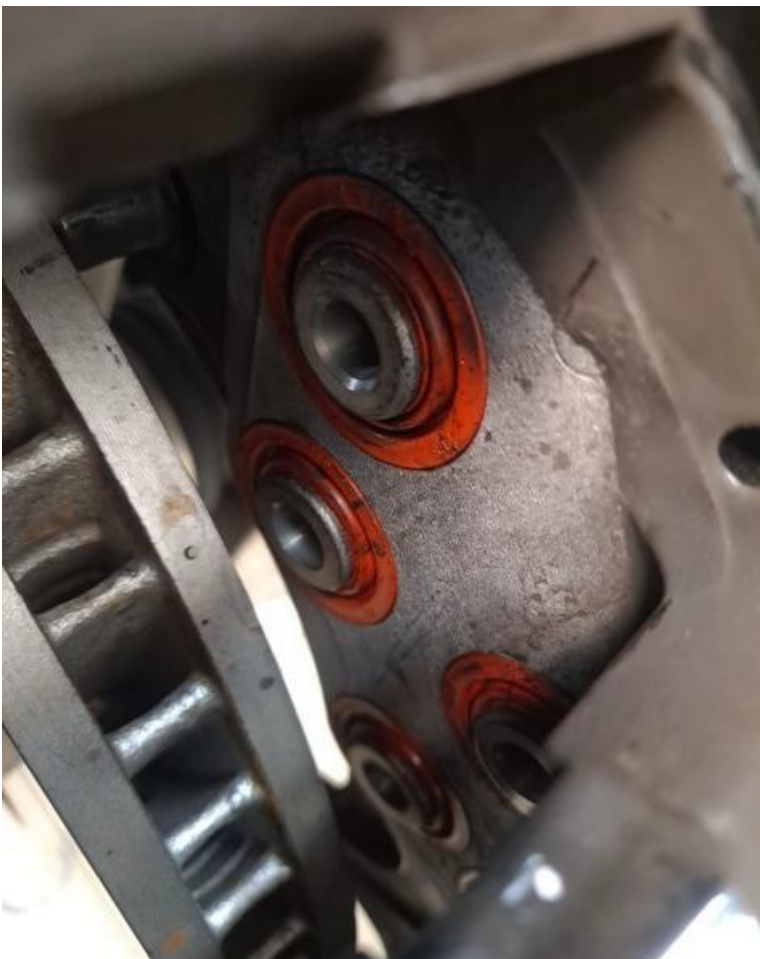
Figure 1

- Inspect the left and right front brake calliper pistons, checking for any excessive assembly wax which may be applied between the calliper and brake pad surfaces (Figures 1 and 2)

4) Using a suitable brake cleaner - Remove the assembly wax from the left and right hand calliper and Calliper pistons

- Using a suitable brake cleaner - Remove the assembly wax from the rear of the front brake pads **IMPORTANT: DO NOT APPLY THE BRAKE CLEANER DIRECTLY TO THE FRICTION SURFACES OF THE BRAKE PADS**
