ADDRESSEES	: Owners and operators of coaches listed under “Application” ABC Customer Care and Parts Source
VEHICLE MODEL	: CX.. MY2020/TX.. MY2020/TDX25 US MY2020
MANUAL SECTION	: 08.02 Climate control – control system
BULLETIN TYPE	: Field Change Program
DATE	: February 2 nd , 2022
SUBJECT	: Check of refrigerant compressor wiring
TERMS & CONDITIONS	: Refer to the warranty section further in this Bulletin.

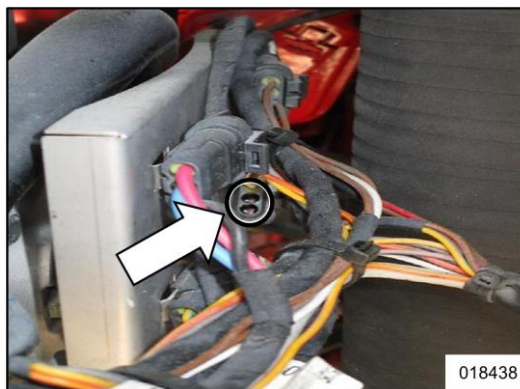
Figure 1

- Plug seals missing at the connector side of the pressure transducers (figure 1).

To address these issues, Van Hool is conducting a Field Change Program. A rubber protection will be added at the top of the plate that holds the connectors. Missing plug seals will be added to the back of the 4-pin connector and the missing connector socket to the open connector on the compressor as well. Check for corrosion, bad pins should be replaced.

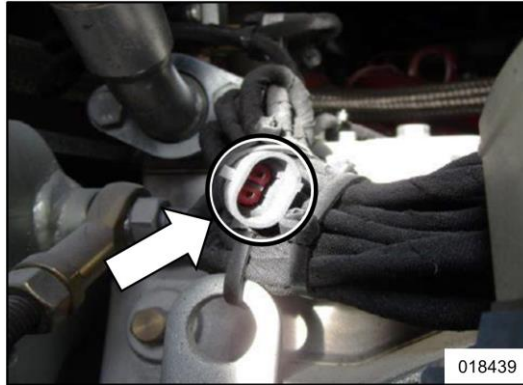
Figure 2

- A connector that is just left open which appears to no longer be connected to anything. Water infiltration will cause corrosion and failure codes (figure 2).

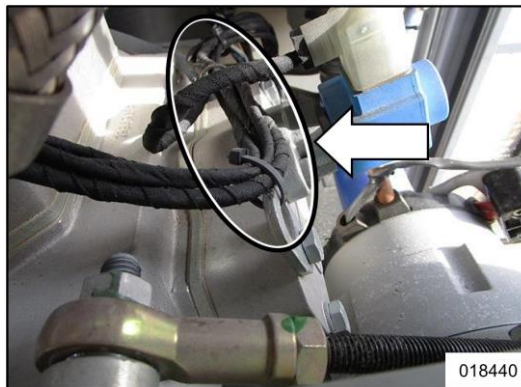
Figure 3

- Some wires are secured with wire ties with sharp corners that can rub through and cause failure codes (figure 3).

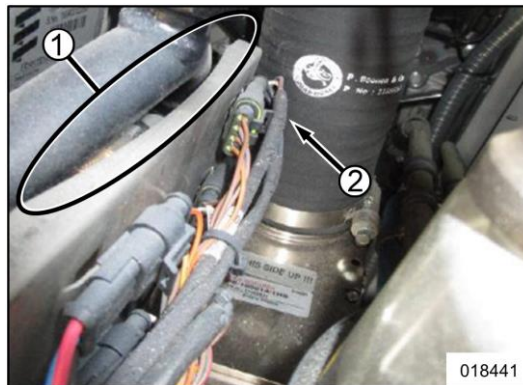
Figure 4

- The plate that holds the connectors is only attached at the bottom, so the top of the plate vibrates and hits the refrigerant compressor suction line (1, figure 4). Vehicles with a Cummins engine have an additional concern with wires hitting the lavatory tube because the compressor sits further towards the engine (2, figure 4).
