TECHNICAL TOPICS

2nd Row Seat Recline Motors Available as Lower Level Assembly

17MY-Onwards Discovery, Range Rover, RR Sport

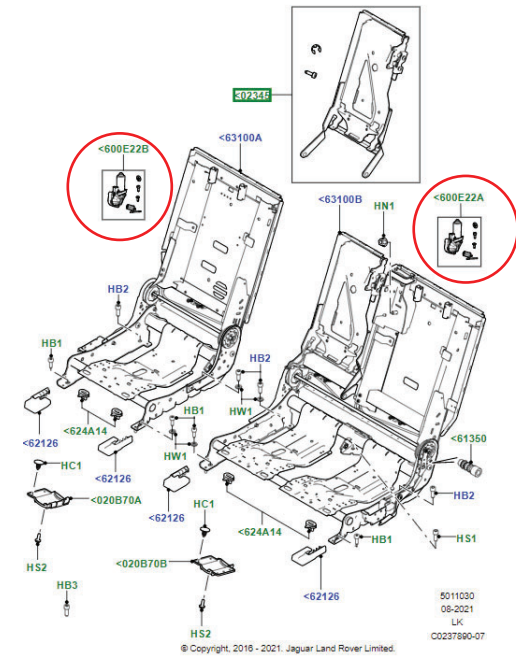
- A customer may report that the 2nd row seat does not recline.

- This may be caused by a seat recline motor malfunction.

- The 2nd row seat recline motors have now been released as a lower level service part.
- Please refer to the Electronic Parts Catalog (EPC) with the VIN for the correct lower level assembly part number should diagnosis of a customer concern identify a recline motor failure.
- The replacement procedure has been added to the Workshop Manual, section 501-10: Seating > Removal and Installation > Rear Seat Recline Motor.
