TECHNICAL TOPICS

BODY/CHASSIS

Seat Cushion Pan Service Kit Available as Lower Level Assembly

17MY-Onwards Range Rover, RR Sport, XF, F-TYPE 15-19MY RR Evoque, 11-20MY XJ

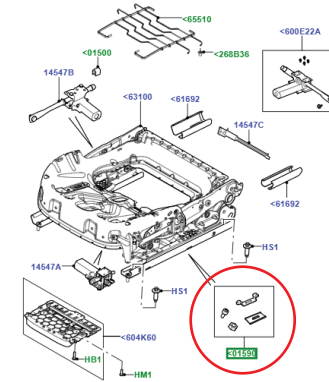
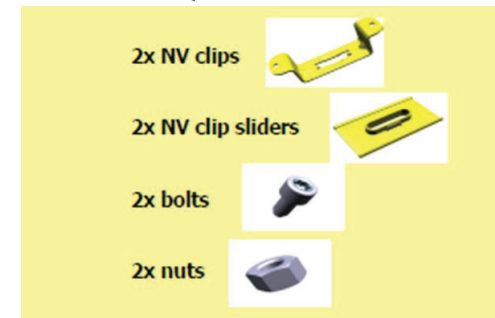
- A customer may report a rattle tyle noise from the front seat base area.

- This may be caused by a seat pan bracket.

- A front seat pan service kit has now been released as a lower level service part to allow a repair to be done in the vehicle without separating the seat cushion from the seat squab.
- Please refer to the Electronic Parts Catalog (EPC) with the VIN for the correct lower level assembly part number should diagnosis of a customer concern identify a seat pan bracket concern.
- The replacement procedure has been added to the Workshop Manual, section 501-10: Seating > General Procedures > Front Row Seat Pan Bracket.
