Technical product information

Bentayga Hybrid

New Flying Spur Hybrid

Charging starts and stops when using a public charging unit

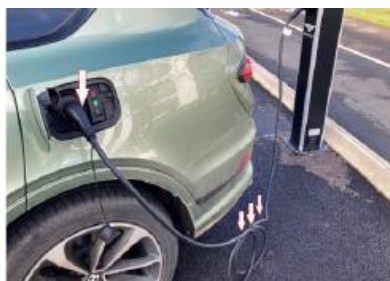
Referring to Figure 1 - Whilst charging the high voltage battery at a public charging unit and the vehicle is unlocked the charge socket locking pin retracts. The unsupported weight of the cable results in the cable relaxing within the charge socket, the charging issue is evident when the vehicle is locked, this is due to the locating pin being unable to lock into place resulting in the charging process being interrupted

5) Advise the customer that when using Public charging equipment, the charge cable should be supported until pin lock has been activated
