Technical product information

Topic	Bentayga Hybrid - Emission control system warning lamp illuminated within the DIP - Open circuit DTC's evident
Market area	Russische Föderation (5RU),Australia E04 Bentley rest Asia and Australia (6E04),China 796 VW Import Comp. Ltd (Vico), Beijing (6796),Germany E02 Bentley rest Europe (6E02),Japan E03 Bentley Japan (6E03),Korea, (South) E08 Bentley South Korea (6E08),United Arab Emirates E06 Bentley Middle East and Africa (6E06),United Kingdom E01 Bentley UK (6E01),United States E05 Bentley USA and rest America (6E05)
Brand	Bentley
Transaction No.	2065697/1
Level	EH
Status	Approval
Release date

Bentayga - Hybrid

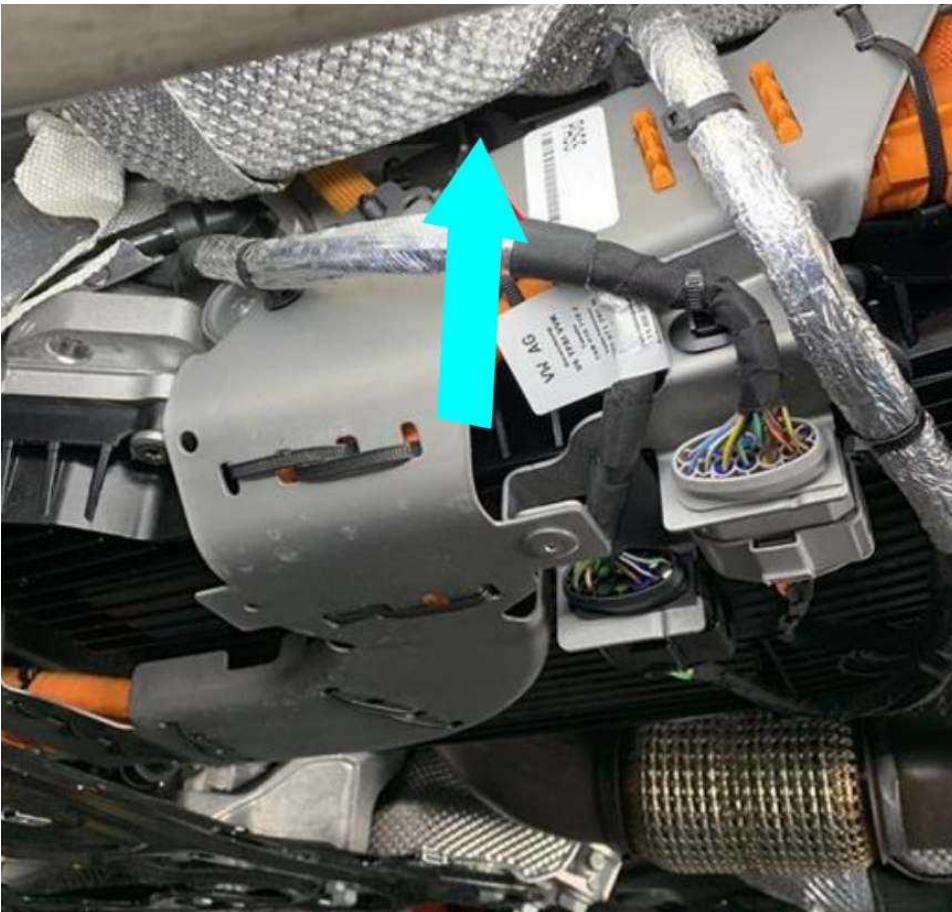
- The operative should identify the location shown in Figure 2 (Left hand side of Transmission)

- Referring back to the fitting location in Figure 2 - Reposition/secure the wiring harness ensuring the wiring harness cannot chaff/contact any of the surrounding components

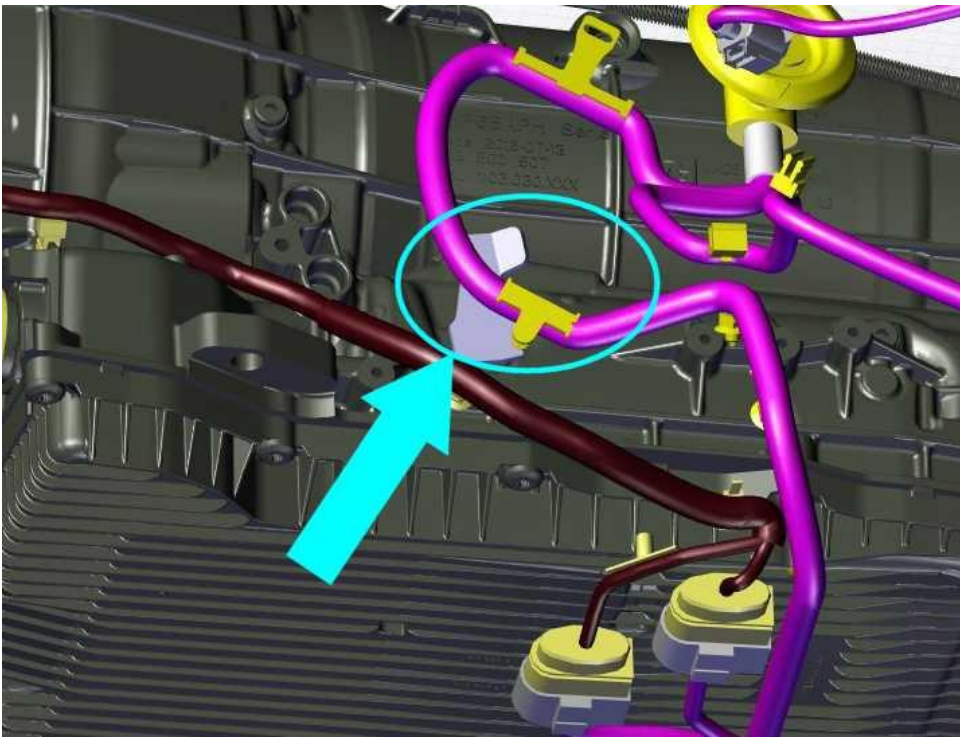
Figure 3

TIP: Referring to Figures 3 and 4 - Consider contact/chaffing between the main body harness and the following components:

- Transmission outer casing webbing
- Floorpanel
- Transmission park lock mechanism

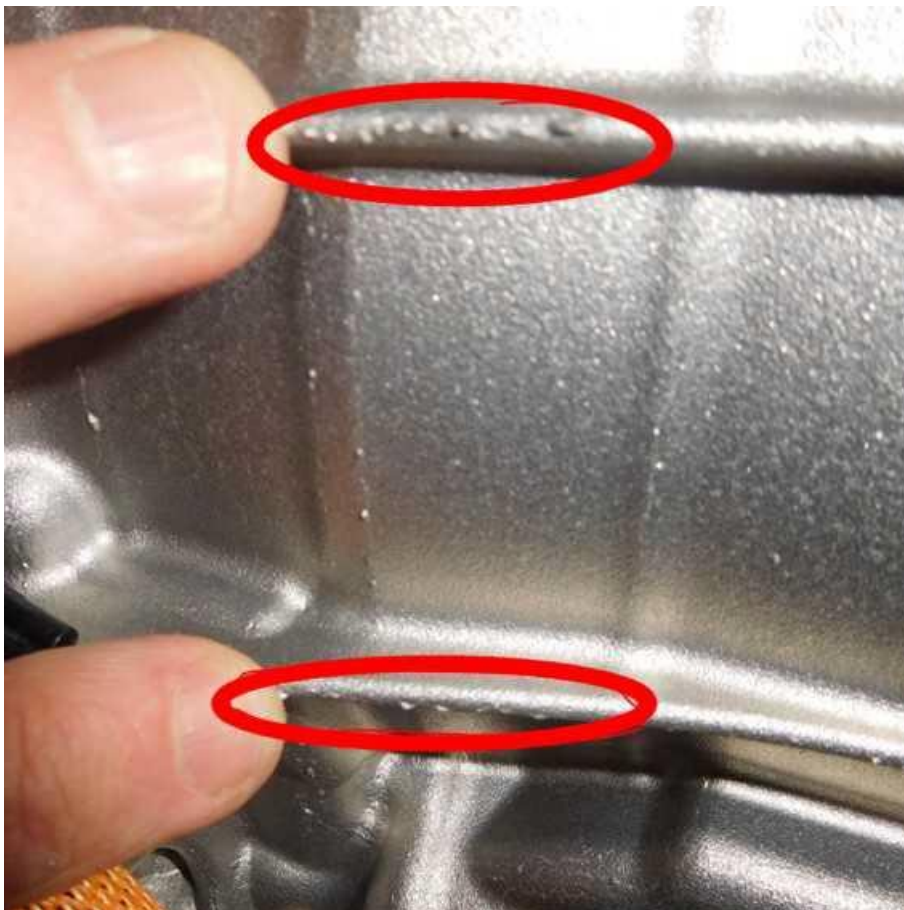
Figure 8

IMPORTANT: Check to confirm the actual point of contact for example: The transmission outer casing webbing (Figure 8)

- In the event that any sharp edges or excess casting spots are evident, the operative should carefully remove any sharp edges with low grade sandpaper for example
