Technical Service Bulletin

SUBJECT:			No: TSB-22-16-002
ENGINE CRANK / NO START IN EXTREME COLD – DTC P062D			DATE: March 2022
			MODEL: 2022 Outlander
CIRCULATE TO:	<input type="checkbox"/> GENERAL MANAGER	<input checked="" type="checkbox"/> PARTS MANAGER	<input checked="" type="checkbox"/> TECHNICIAN
<input checked="" type="checkbox"/> SERVICE ADVISOR	<input checked="" type="checkbox"/> SERVICE MANAGER	<input checked="" type="checkbox"/> WARRANTY PROCESSOR	<input type="checkbox"/> SALES MANAGER

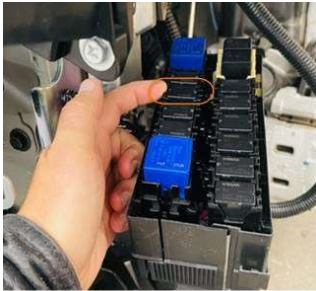
Photo of front relay box behind front bumper	relay identification
	1 PWM (RAD FAN) relay
	2 ST cut relay
	3 VINJ (INJ) relay
	4 WIPER DEICER relay
	5 H/L washer relay (AWD)
	6 OFF LOAD 2 ION 3 (seat heater) relay
	7 FR WASHER MTR
	8 RR WASHER MTR
	9 SR MTR (A/T)
	10 SR MTR (A/T)
	11 REV LAMP
	12 PTC 1
	13 PTC 2
	14 PTC 3

- Remove the relay box cover.
- Turn IG-OFF and replace the 4 relays indicated below (INJ, ST CUT, SR MTR x 2).

- Reinstall all components and tighten the torque of the relay box bracket to: $5 \pm 1 \text{ N}\cdot\text{m}$.
