Technical product information

Topic	Air suspension warning light within the DIP - DTC's P089200 - C104707 - C103B13 - Evident within Address 74
Market area	Russische Föderation (5RU),Australia E04 Bentley rest Asia and Australia (6E04),China 796 VW Import Comp. Ltd (Vico), Beijing (6796),Germany E02 Bentley rest Europe (6E02),Japan E03 Bentley Japan (6E03),Korea, (South) E08 Bentley South Korea (6E08),United Arab Emirates E06 Bentley Middle East and Africa (6E06),United Kingdom E01 Bentley UK (6E01),United States E05 Bentley USA and rest America (6E05)
Brand	Bentley
Transaction No.	2062259/4
Level	EH
Status	Approval
Release date

New Continental GT /GTC (Including Speed) & New Flying Spur

Air suspension warning light within the DIP

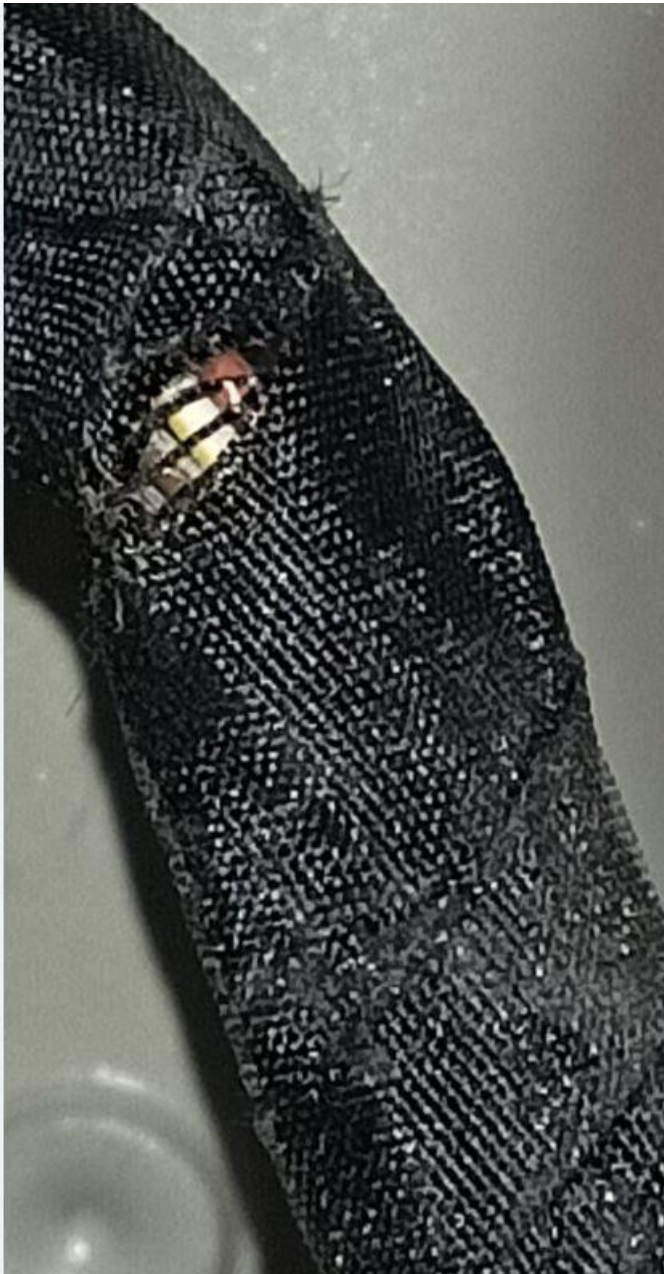
- Broken wires
- Kinked wiring
- Pin/s missing
- Pin/s broken
- Pin/s loose

NOTE: Refer to the example shown in Figure 1 of a damaged wiring harness

2) Repair any broken or damaged wires as per Rep.Gr 97
