Technical product information

Topic	Electronic Parking Brake (EPB) functionality issues
Market area	Russische Föderation (5RU),Australia E04 Bentley rest Asia and Australia (6E04),China 796 VW Import Comp. Ltd (Vico), Beijing (6796),Germany E02 Bentley rest Europe (6E02),Japan E03 Bentley Japan (6E03),Korea, (South) E08 Bentley South Korea (6E08),United Arab Emirates E06 Bentley Middle East and Africa (6E06),United Kingdom E01 Bentley UK (6E01),United States E05 Bentley USA and rest America (6E05)
Brand	Bentley
Transaction No.	2062184/5
Level	EH
Status	Approval
Release date

New Continental GT/GTC and New Flying Spur

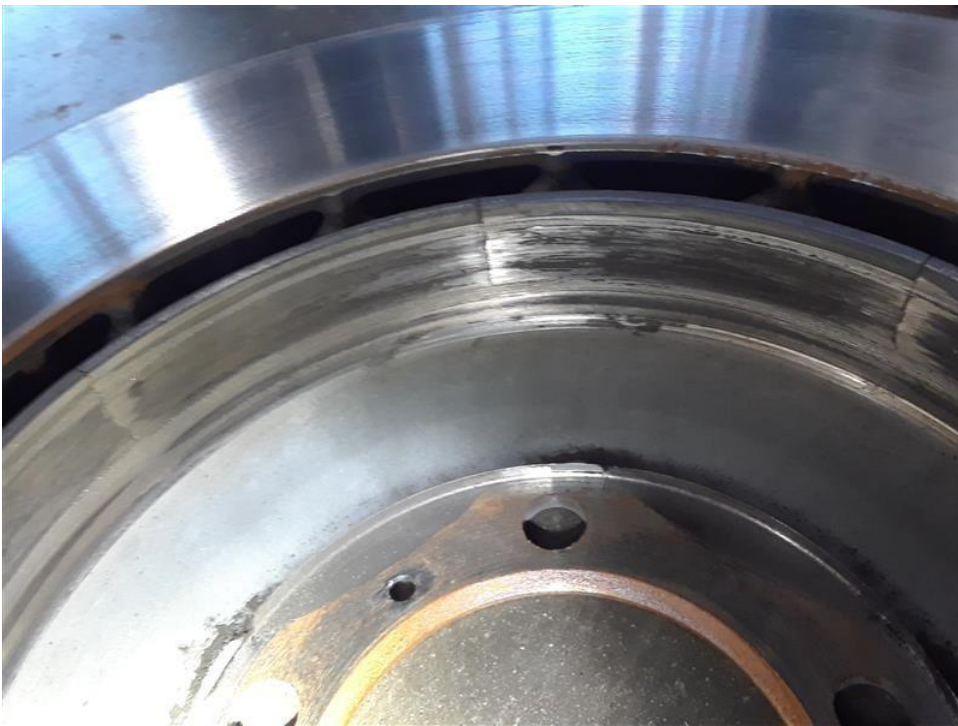
- Right and left hand rear brake discs - See example shown in Figure 3

1) Carry out a full inspection of the (Electronic Parking Brake EPB) system including the following components:
