# Technical product information

<b>Topic</b>	PDC system not working or PDC system false detection
<b>Market area</b>	Russische Föderation (5RU),Australia E04 Bentley rest Asia and Australia (6E04),China 796 VW Import Comp. Ltd (Vico), Beijing (6796),Germany E02 Bentley rest Europe (6E02),Japan E03 Bentley Japan (6E03),Korea, (South) E08 Bentley South Korea (6E08),United Arab Emirates E06 Bentley Middle East and Africa (6E06),United Kingdom E01 Bentley UK (6E01),United States E05 Bentley USA and rest America (6E05)
<b>Brand</b>	Bentley
<b>Transaction No.</b>	2066393/1
<b>Level</b>	EH
<b>Status</b>	Approval
<b>Release date</b>

## New Continental GT/C and New Flying Spur

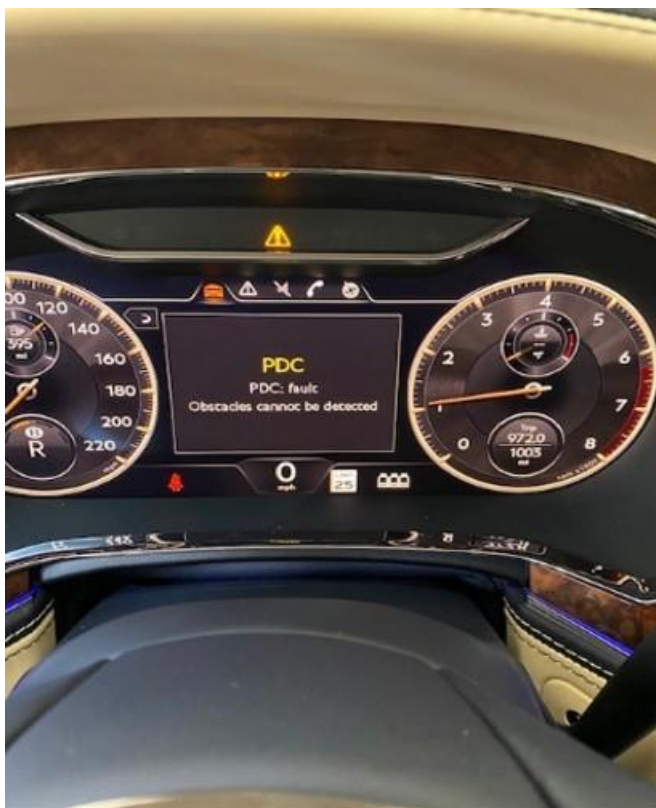
Figure 1

- PDC system not working or PDC system false detection
- Warning evident within the DIP (Figure 1)

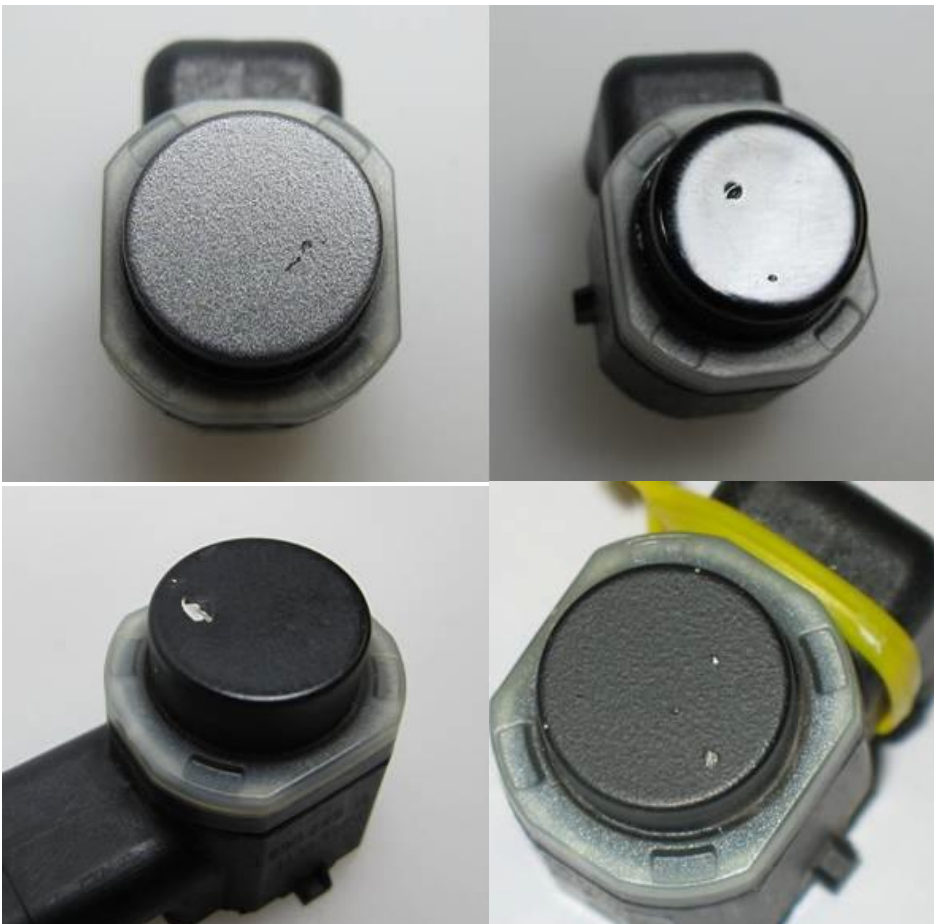
- Dirt, ice, foreign bodies, foil stuck on
- Check any damage on the bumper, air inlet grille and underbody which may indicate a parking accident
- Mechanical damage (stone chips, scratches)

IMPORTANT: With the following examples stone chips led to the failure of the sensor:

Stone chips and scratches are not complaints in the sense of warranty. Therefore dirty sensors should be cleaned and not replaced

Any sensors which are replaced for stone chips, scratches or any other type of damage will not be approved for warranty payment

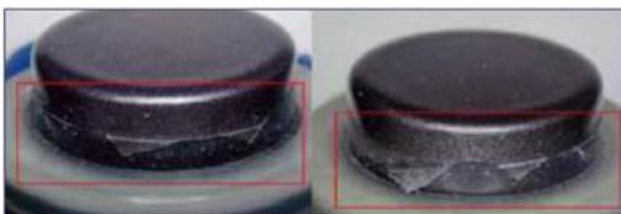
9. when painting sensors ensure to paint within area specifications, removable layers of paint on the membrane can lead to false signals
