Technical product information

Topic	Warnings within the DIP for the rear steering system - DTC P060700 evident within diagnostic address 00CB
Market area	Russische Föderation (5RU),Australia E04 Bentley rest Asia and Australia (6E04),China 796 VW Import Comp. Ltd (Vico), Beijing (6796),Germany E02 Bentley rest Europe (6E02),Japan E03 Bentley Japan (6E03),Korea, (South) E08 Bentley South Korea (6E08),United Arab Emirates E06 Bentley Middle East and Africa (6E06),United Kingdom E01 Bentley UK (6E01),United States E05 Bentley USA and rest America (6E05)
Brand	Bentley
Transaction No.	2066511/1
Level	EH
Status	Approval
Release date

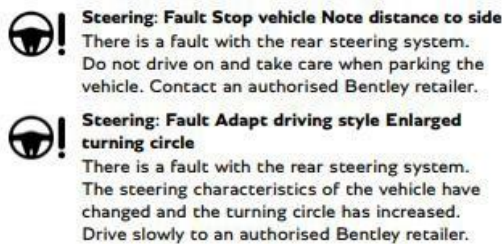
Figure 1

- Warnings within the DIP for the rear steering system (Figure 1)

- DTC P060700 evident within diagnostic address 00CB - Rear Axle Steering control module

1) Inspect the rear wheel steering control unit /J1019 (rear steering rack) for signs of the following:

2) Referring to the applicable wiring diagram, conduct an electrical integrity check for the rear wheel steering control unit /J1019 (rear steering rack)

- Refer to the applicable wiring diagram - Check earth point 710 for Cleanliness, security and integrity
- If no faults were identified after conducting the wiring integrity checks - Refer to Rep.Gr 48 - Replace the rear wheel steering control unit /J1019 (rear steering rack)
