Technical product information

Topic	P245000 - EVAP System Switching Valve "A" Performance/Stuck Open DTC logged - V8 Kovomo
Market area	China 796 VW Import Comp. Ltd (Vico), Beijing (6796),United States E05 Bentley USA and rest America (6E05)
Brand	Bentley
Transaction No.	2063678/3
Level	EH
Status	Approval
Release date

New Continental GT/GTC and New Flying Spur - V8 Kovomo

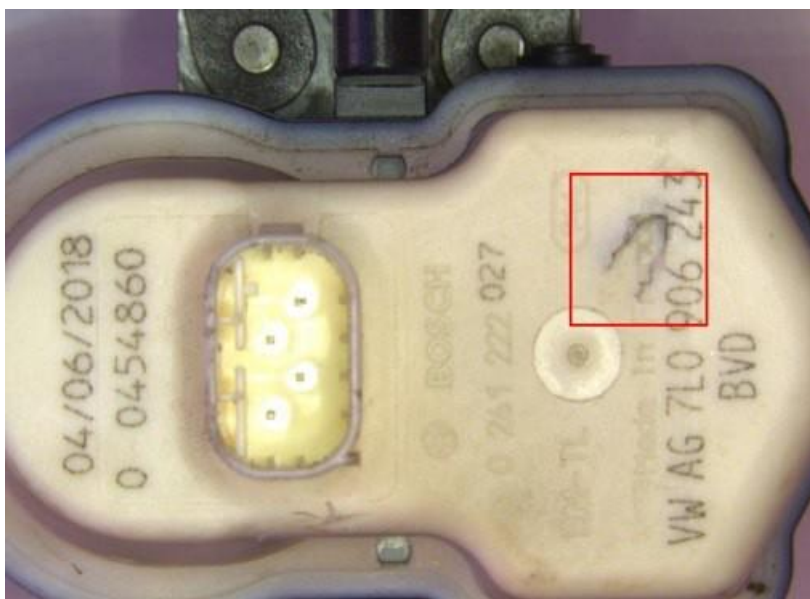
Figure 2

- 1) Referring to the applicable wiring diagram conduct a wiring integrity check of the Leak Detection Pump wiring circuit and connectors
- 2) Perform a smoke test of the leak detection system - Monitor for any leaks
- 3) If no faults were found - Refer to Rep.Gr 20 - Replace the leak detection pump (V144)
- 4) Inspect the LDP for impact damage when extracted, the operative must provide feedback and photographic evidence (see example shown in Figure 2) via a new or existing DISS query
