Technical Service Bulletin

SUBJECT:		No: TSB-22-42A-001	
DRIVER'S SIDE WINDOW SWITCH INOPERATIVE		DATE: March 2022	
		MODEL: See Below	
CIRCULATE TO:	<input type="checkbox"/> GENERAL MANAGER	<input checked="" type="checkbox"/> PARTS MANAGER	<input checked="" type="checkbox"/> TECHNICIAN
<input checked="" type="checkbox"/> SERVICE ADVISOR	<input checked="" type="checkbox"/> SERVICE MANAGER	<input type="checkbox"/> WARRANTY PROCESSOR	<input checked="" type="checkbox"/> SALES MANAGER

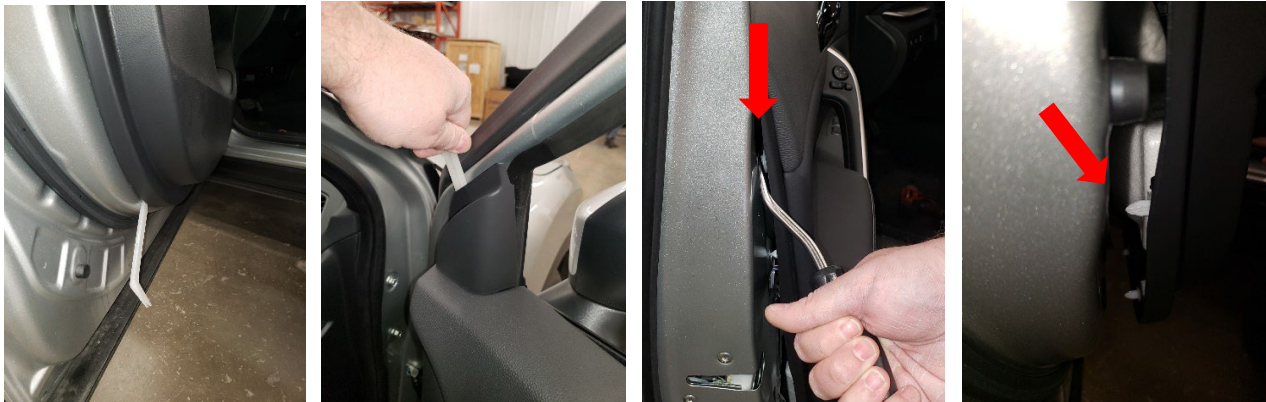
5. When removing the door panel, use extra caution with the top left clip (see image below) as it will easily break.

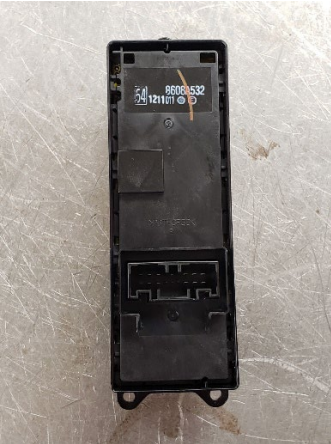
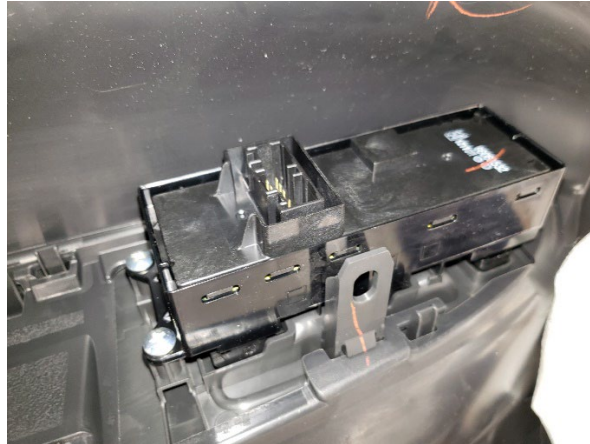
The Driver's Side Window Switch may become inoperative during certain conditions when using the one touch function to open/close the window.

7. Replace old SWITCH, P/W MAIN with a new one.
