69-22-01 - Airbag Light ON, DTCs B100B1B or B100A1B Stored

Release date: 4/6/2022

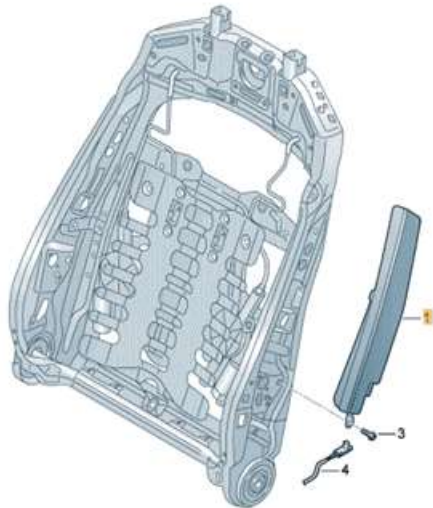
Inspect affected seat wiring harness connectors before replacing any components.

DTC	Description
B100B1B	Driver Thorax Airbag - N199 - Ignitor Resistance Too High
B100A1B	Front Passenger Thorax Airbag - N200 - Ignitor Resistance Too High

- Remove affected seat back rest. See Repair Group number 72 in Elsa.
- Disconnect the Front Thorax Airbag wiring connector following the strict repair information in Elsa. See Repair Group 69.
- Inspect the thorax airbag wiring end connector (4) for damage or poor connection (incorrect harness end connection, pushback pins, wire routing etc), repair as necessary. See Repair Group 97 in Elsa.
- If no wiring damage is noted, reconnect the Thorax Airbag with ignitor.
- Reassemble the seat.
- Clear DTC memory.
- Road Test.
- If Airbag light reoccurs, verify same fault code for thorax airbag and replace the seat harness and airbag.
