Applicable Vehicles					
Model(s)	Year	Eng. Code	Trans. Code	VIN Range From	VIN Range To
All (except Routan)	1996-2022	All	All	All	All

Condensation and or water droplets visible on inside of exterior light lenses.

94-19-01 - Exterior Lights, Moisture Accumulation

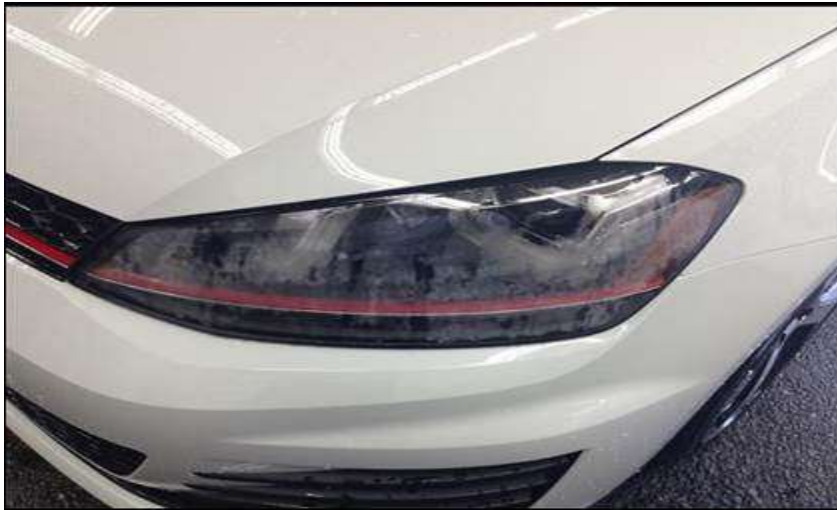
Figure 1

Exterior light assemblies (headlights, taillights with incandescent bulbs, fog lights, turn signals) are vented and may collect moisture on their inner surfaces, depending on humidity and climatic conditions. The unfavorable condensation built up (Figure 1) visible to the customer is more common with modern exterior lights because of clear glass optics, however this condition will not have an impact on the functionality or durability of the component.

For headlight condensation that is due to environmental conditions, the affected lens surface should be cleared after approx. 30 minutes of light operation.

If the condition is determined to be condensation due to environmental conditions and no damages are found, explain to the customer the information provided in the Technical Background section above.

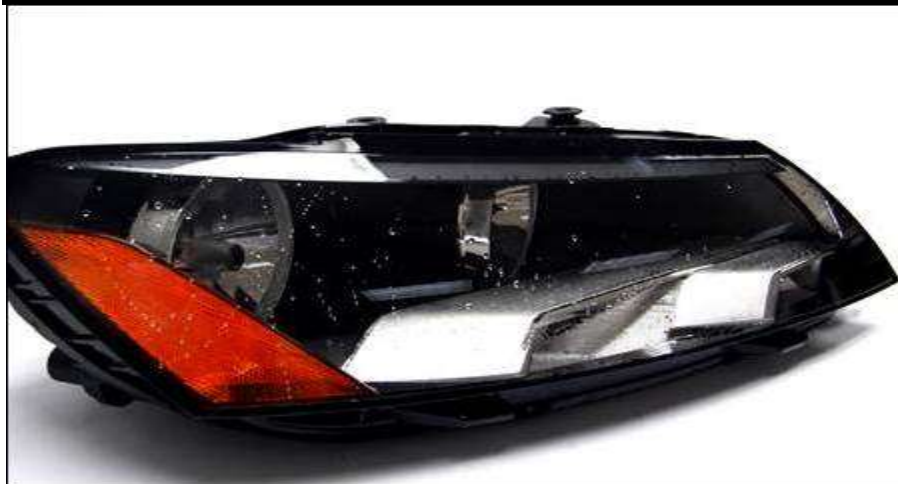
Figure 2

In cases where larger water droplets have formed on the inside of the lens or significant amount of water has collected at the bottom of a light assembly, Figure 2:

- Check for leaking seals, cracks in lenses or assemblies.

DO NOT replace light or lens assemblies unless damage is found.

If damage to seals or cracks to lenses or assemblies are found:

- Follow normal repair procedures for this type of failure (provide photograph(s) with repair documentation for verification).
