Technical Service Bulletin

46 Brake noise analysis and handling

46 22 30 2034181/20 April 7, 2022. Supersedes Technical Service Bulletin Group 46 number 22-27 dated January 31, 2022, for reasons listed below.

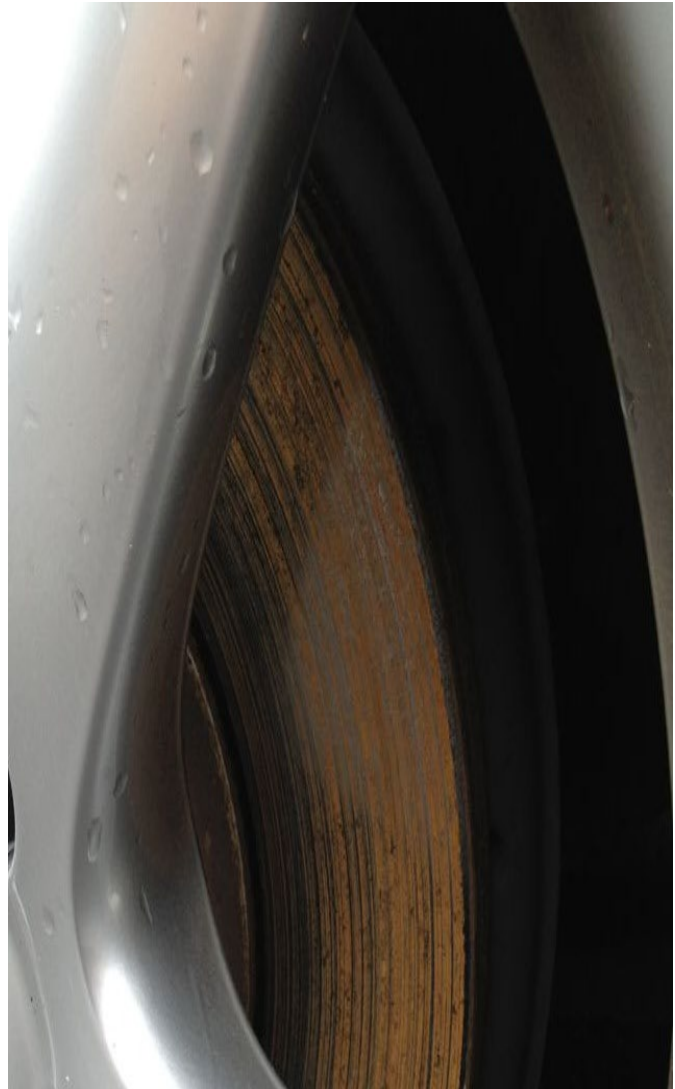
3. Aftermarket pads or discs are installed.
4. There is debris (such as small stones, grit, road salt, or sand) between the brake disc and brake pad.
5. Discs are covered with rust. Rust can form when the vehicle has not been driven for a long period of time (Figure 1).

Figure 1. Disc covered with rust.

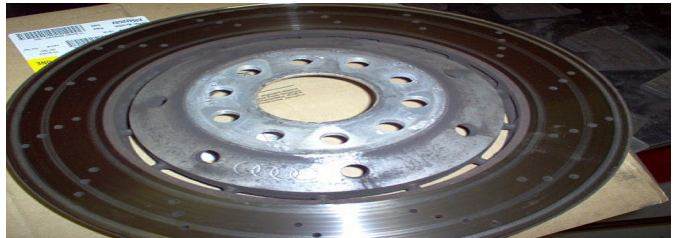
6. Discs are grooved (Figure 2).

Figure 2. Grooved disc.

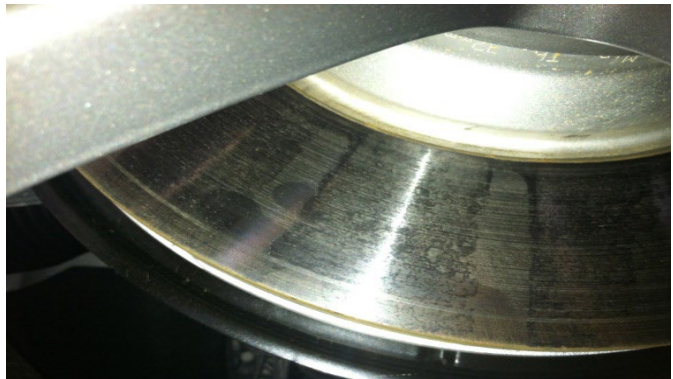
7. There is chemical contamination on the braking surface of the brake disc due to wheel or tire cleaner being sprayed directly onto the brake disc (Figure 3 and Figure 4).

Figure 3. Discoloration on the brake disc due to chemical contamination from the cleaner that was sprayed directly onto the disc.

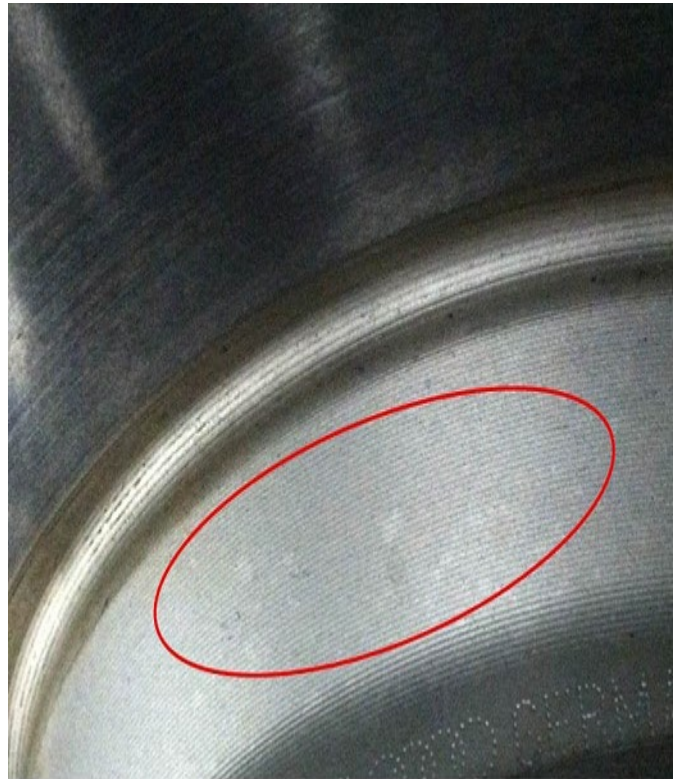
Figure 4. Small spots and discoloration due to chemical contamination from the cleaner that was sprayed directly onto the disc.

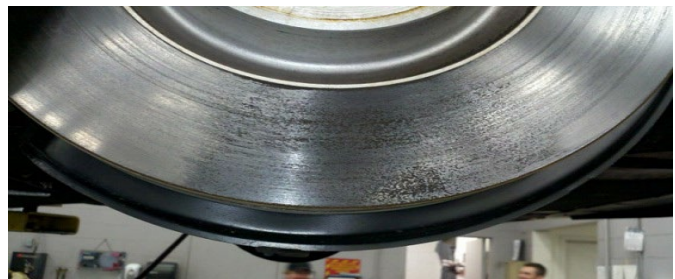
8. There are “pad marks” on the brake disc as a result of brake pad material transferring to the discs (Figure 5). Pad marks can occur when a vehicle has been parked for long periods of time in a wet or snowy environment.

Figure 5. Brake pad material has transferred to the discs.
