GROUP	MODEL
TRA	2019-2021MY Multiple Models w/IVT
NUMBER	DATE
102	April 2022

TECHNICAL SERVICE BULLETIN

IVT SOFTWARE LOGIC IMPROVEMENT AND/OR IVT REPLACEMENT

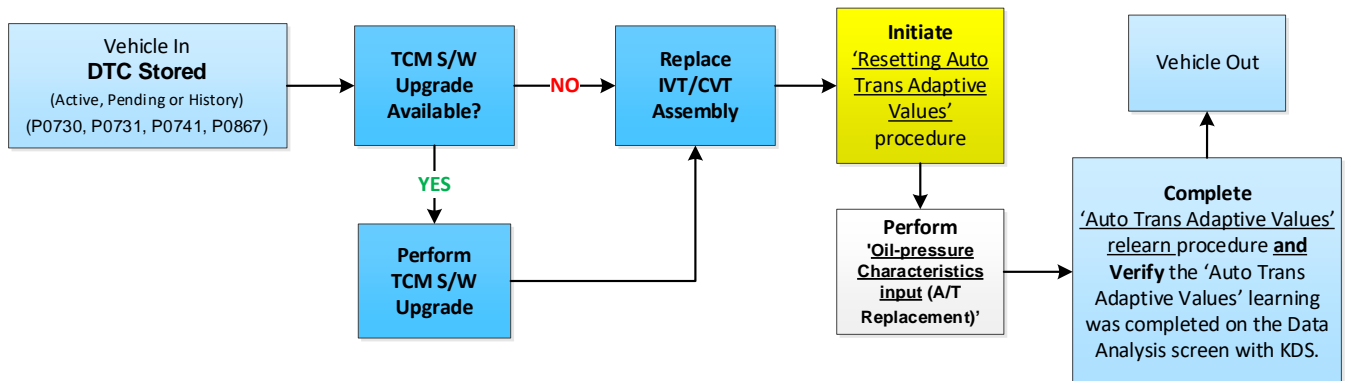
Flowchart:

If the vehicle previously had a TCM software upgrade or IVT replaced, confirm all procedures have been followed correctly as noted in the Flowchart on page 2.
