### PIP5706A Rough Running, Reduce Engine Power, Service Engine Soon (SES) light on, P0123 and P0222

#### Models

Brand:	Model:	Model Years:	VIN:		Engine:	Transmissions:
			from	to		
Chevrolet	Silverado 2500/3500	2020 - 2021	All	All	6.6L L8T	All
GMC	Sierra 2500/3500	2020 - 2021	All	All	6.6L L8T	All

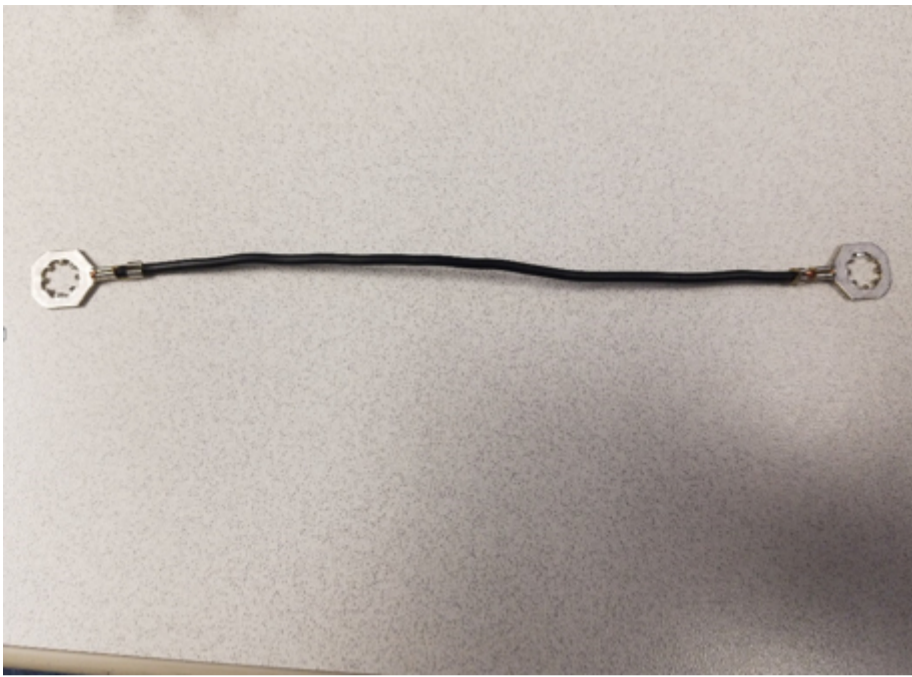
Involved Region or Country	North America
Condition	<b>A vehicle may come into the dealer with a rough idle and /or reduced engine power . Upon inspection the technician may find the SES lamp is illuminated and DTC 's P0123 and P0222 may be active or stored history . This condition may be more noticeable in very cold climates. Note: This PI only applicable to failures that have resulted from vehicles being exposed to extreme cold (-10F / -23C or colder)</b>
Cause	<b>This condition may be caused by an internal circuit board fault within the throttle body .</b>

- 1. Replace throttle body following the service procedure as outlined in service information.**
- 2. Using two 8mm ring terminals and one 8-inch piece of wire 14-gauge wire to make a ground wire as shown below:**
