Preliminary Information

PIT5847C SES Light - Reduced Power - DIC Warning Messages - Reduced Steering Message - Stabilitrack Message

Models

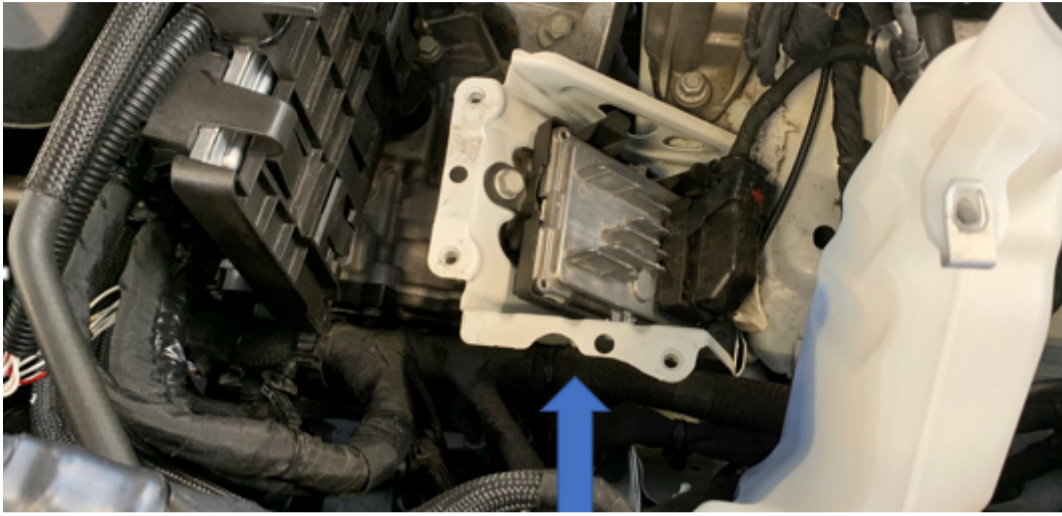
Battery and battery tray are removed to show the area of concern.

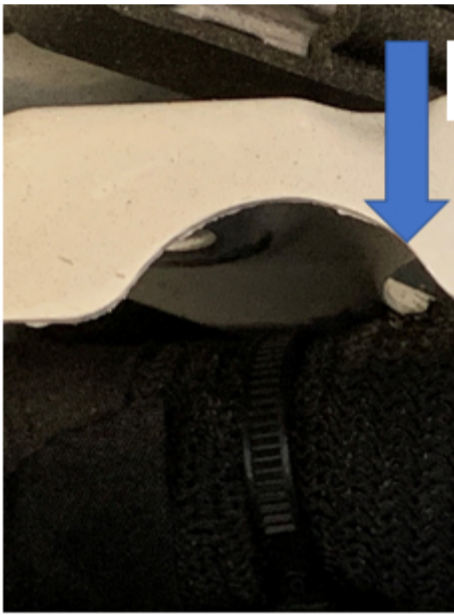
Close up of area where harness may chafe.

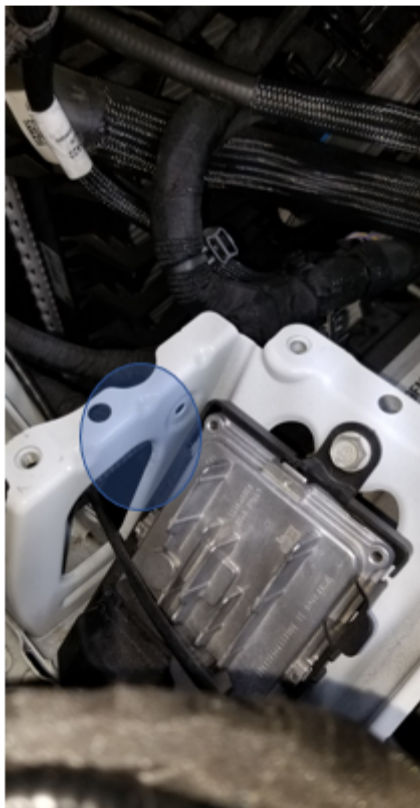
Harness may chafe in the areas shown in the photos above and below.

Reroute or properly secure the harness to prevent further damage.

It may also be necessary to install a piece of heater hose, conduit or both over the harness to prevent a reoccurrence of the concern.

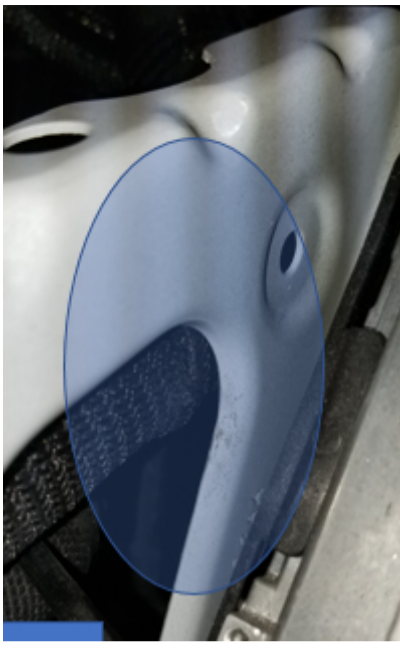
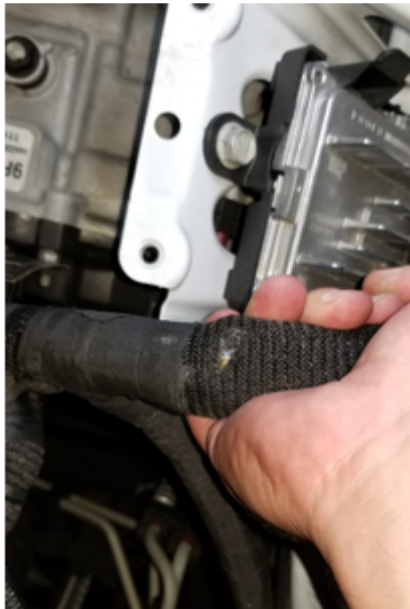
Above shows a harness that was chaffed by the bracket.

If damage is found repair any damaged circuits and tape up the harness.
