TO: Mercedes-Benz Principals, General Managers, Sales Managers, Service Managers, Parts Managers	FROM: Anthony Washington, Department Manager, Regulations and Certifications
Re: Recall Campaign Launch Notification Model 907 (Sprinter) Model Years 2021 Replace Tire and Loading Information Label	DATE: March, 2022

Campaign No. 2022030008 March, 2022

SUBJECT: **Model 907 Sprinter, Model Year 2021**
Replace Tire and Loading Information Label

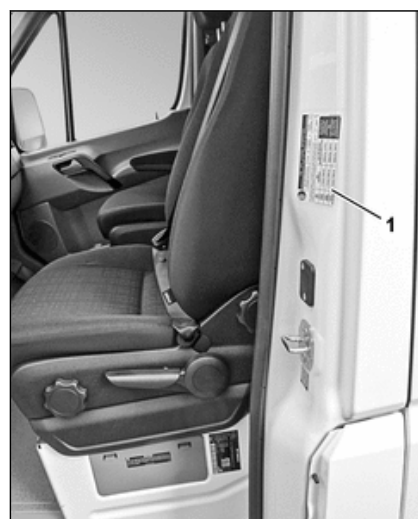
D40.10-1127-02

Mercedes-Benz AG (“MBAG”), the manufacturer of Mercedes-Benz & Freightliner Sprinter vans, has determined that on certain 907 (VS30) platform Sprinter vehicles, the tire and loading information label on the B-pillar could contain erroneous values that overstate the Gross Vehicle Weight Rating. Due to erroneous values for the maximum permissible combined vehicle weight on the tire and loading information label on the B-pillar, overloading of the vehicle could exceed the permissible total weight. As a consequence, over time, this could cause excessive tire wear and in a worst case scenario, could lead to tire failure, which could increase the risk of a crash. MBUSA/DVUSA is conducting a voluntary recall. An authorized Mercedes-Benz/Freightliner Sprinter dealer will check the tire and loading information label and replace it with a corrected label. Additionally, a visual inspection of the tires for excessive wear will be conducted. If necessary, tires with excess wear will be replaced on the affected axles.

1 Tire pressure table information label

Replace		
2 WS	Replace tire pressure table information label (1). 000 588 00 84 00 Heat gun	<p>

Removal: Do not heat the B-pillar under the tire pressure table information label (1) too much. Otherwise the paint will be damaged.</p> <p>

Removal: To do so, remove the old tire pressure table information label (1) with a suitable tool and remove adhesive residue with a suitable cleaning agent.</p>	WS54.00-P-0049B
3	Attach protective foil at tire pressure table information label (1).

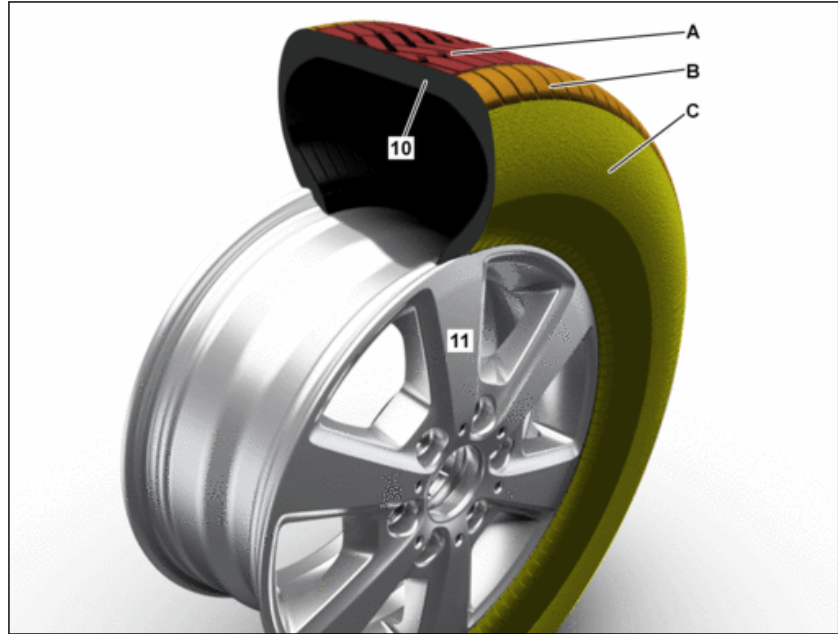
D40.10-A008-76

Schematic diagram of tire structure

If the air pressure of the tires (10) is incorrectly adjusted, the wear at the tire shoulders (B) may be significantly increased in particular.</p> <p>If tire shoulders (B) do not exhibit any increased wear, ↓ Continue with operation step 7 and end measure.</p> <p>If tire shoulders (B) exhibit increased wear, ↓ continue with operation step 5.</p>

Replace		
6 AR	Replace tires (10) of affected axle.	<p>i Always replace tires (10) on an axle-by-axle basis.</p> <p>i Tire specifications for the order can be found in the previously installed tires (10).</p>	AR40.10-D-1030TS
7	Lower vehicle.
