Service Bulletin

Bulletin No.: 22-NA-079

Subject: Poor Engine Performance in Extremely Cold Weather Conditions for LSY Engines, Charge Air Cooler Icing, Malfunction Indicator Lamp (MIL) Illuminated with P0299

Brand:	Model:	Model Year:		VIN:		Engine:	Transmission:
		from	to	from	to		
Buick	Envision	2021	2022			LSY

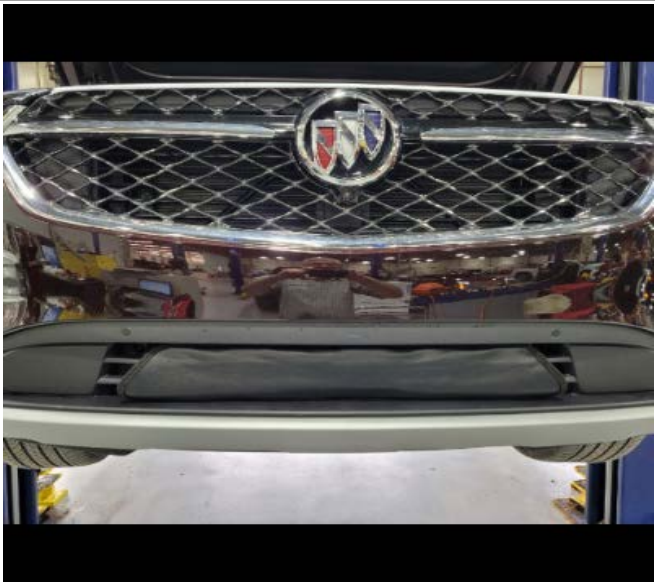
Involved Region or Country	North America
Additional Options (RPOs)	Equipped with LSY Engines only
Condition	<p>Some customers may comment on one or more of the following conditions when driving in extremely cold weather conditions (-18°C or less / 0°F or less):</p> <ul style="list-style-type: none"> • Loss of power • Hesitation on acceleration • Stalling condition • Malfunction Indicator Lamp illuminated P0299
Cause	This condition may be caused by ice accumulation in the charge air cooler (CAC), restricting air flow.
Correction	<div style="text-align: center;">

</div> <p style="text-align: right; font-size: small;">6029252</p> <p>A winter grille cover has been released to address this issue.</p>

Instructions for installation are included with the grille cover.
