Technical Service Bulletin

68 Rear window sunshade on rear hatchgate does not retract

68 22 36 2043852/2 April 16, 2022. Supersedes Technical Service Bulletin Group 68 number 16-18 dated May 11, 2016, for reasons listed below.

Model(s)	Year	VIN Range	Vehicle-Specific Equipment
2017	Q7	000001 – 002241	Not Applicable

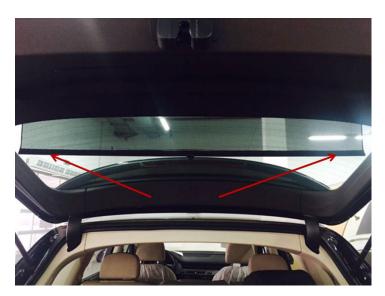
When the rear window sunshade is lowered, the material does not fully retract into its cassette (Figure 1).

Figure 1. Rear window sunshade has lost its tension and does not fully retract.

The recoil mechanism in the rear window sunshade is faulty. As a result, the shade material hangs loosely on the rear lid lower trim panel.

Remove the rear lid lower trim panel and replace the rear window sunshade assembly.
