# Technical Service Bulletin

## 72 Rear backrest release in the luggage compartment is inoperative

72 22 42 2062113/4 April 16, 2022. Supersedes Technical Service Bulletin Group 72 number 21-35 dated July 16, 2021, for reasons listed below.

Model(s)	Year	VIN Range	Vehicle-Specific Equipment
A4 allroad	2017	All	Not Applicable
A5, A5 Cabriolet, and RS 5	2018 – 2023

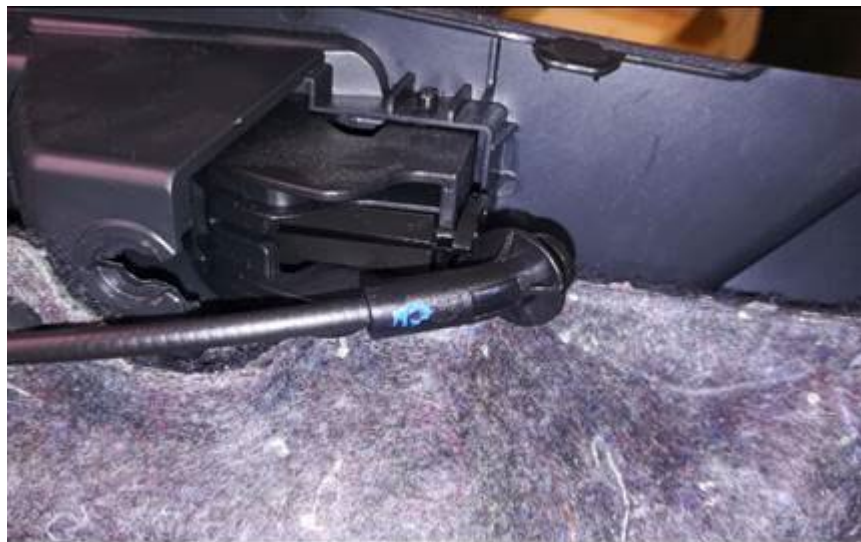
The backrest release levers in the luggage compartment do not provide feedback/resistance when pulled. The levers feel loose. The backrests only move forward approximately 1/8 inch and the red backrest latch markings protrude. The backrests do not fold forward.

The Bowden cable disengages from its attachment point and does not release the backrest latch.

In some cases, this results in damage to the Bowden cable or to its attachment point in the luggage compartment side trim.

1. If the second-row backrest release lever is without resistance or feels loose, the Bowden cable in the luggage compartment side trim has become disengaged (Figure 1).

*Figure 1. Bowden cable is disengaged from the attachment point.*

2. Remove the luggage compartment side trim of the affected side according to the repair manual in Elsa.
3. Inspect the Bowden cable and the backrest release mechanism for any damage.

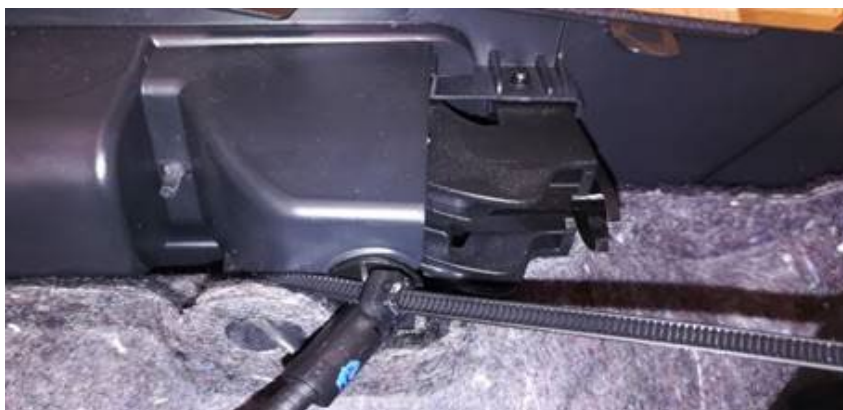
*Figure 2. The Bowden cable; reinstalled and secured with a tie wrap.*

4. Reinstall the Bowden cable in the backrest release mechanism and secure it with a tie wrap (Figure 2).

5. Check the operation of both backrest release levers in the luggage compartment.
6. Reinstall the luggage compartment side trim.
