Technical Service Bulletin

87 Air conditioning refrigerant circuit diagnostic method using calibration gas
87 22 24 2064077/1 April 15, 2022.

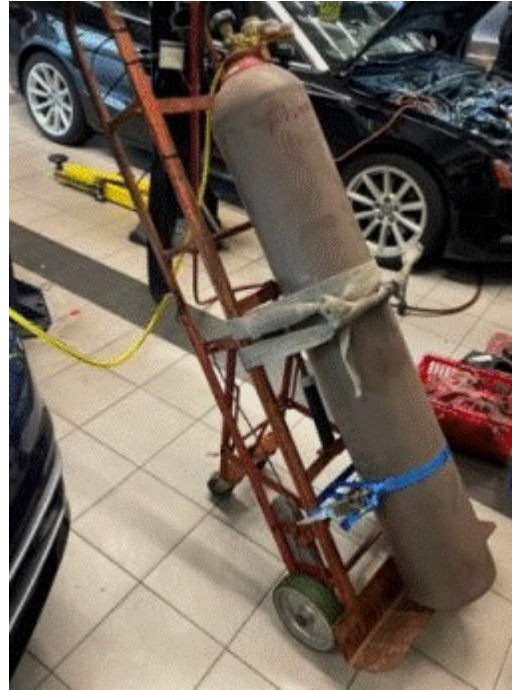
Figure 1. Calibration gas (95% Nitrogen / 5% Hydrogen).

2. Obtain a tank of calibration gas (95% nitrogen / 5% hydrogen) (Figure 1). This will need to be sourced locally (e.g. Airgas®).

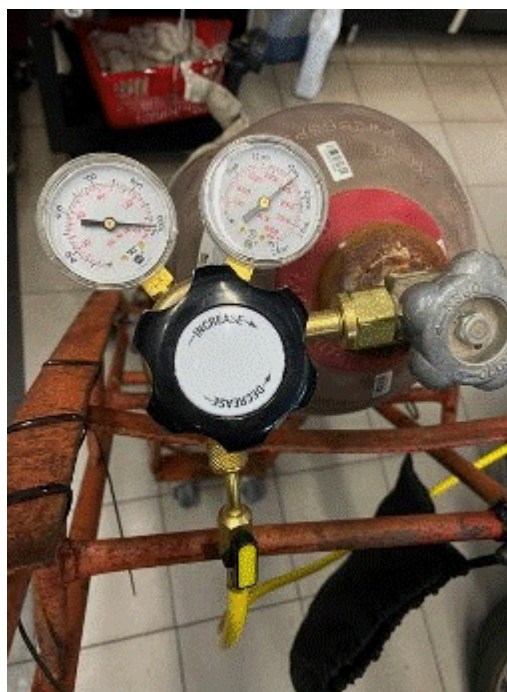
Figure 2. VAS 584005 pressure regulator attached to the calibration gas tank.

- The pressure regulator included in the NITROKITG will not be used as it is only suitable for connection to a gas tank containing non-flammable gasses such as nitrogen (right-hand thread). The AT-448 Tool Set includes the VAS 584005 pressure regulator suitable for connection to a gas tank containing any flammable component as is the case with the hydrogen component in calibration gas (left-hand thread). Connect the VAS 584005 pressure regulator to the tank (Figure 2). Make sure the tank valve remains closed.

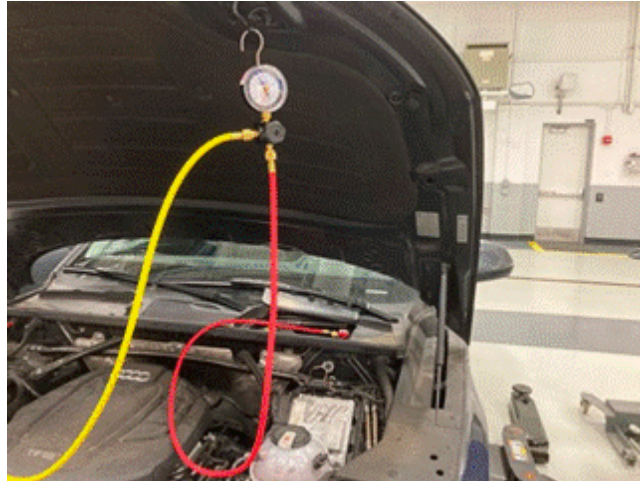
Figure 3. NITROKITG manifold connected to the high side service port.

7. Evacuate the vehicle refrigerant circuit for 15 minutes. After the refrigerant circuit is free of any refrigerant connect the service manifold from the NITROKITG Automotive A/C Nitrogen Leak Test Kit to the high side service port. Use the appropriate snap coupler for the platform of the circuit being serviced. (Figure 3).

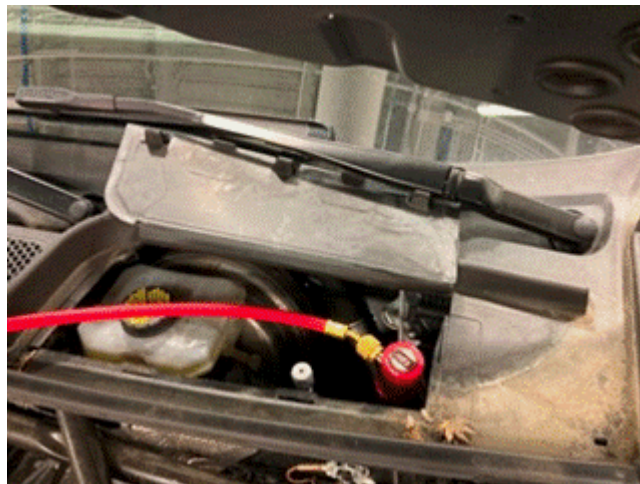
Figure 4. NITROKITG high side snap coupler connected to the high side service port.

8. Only one of the ports needs to be connected for this diagnosis. The connection to the high side port is shown in Figure 4.

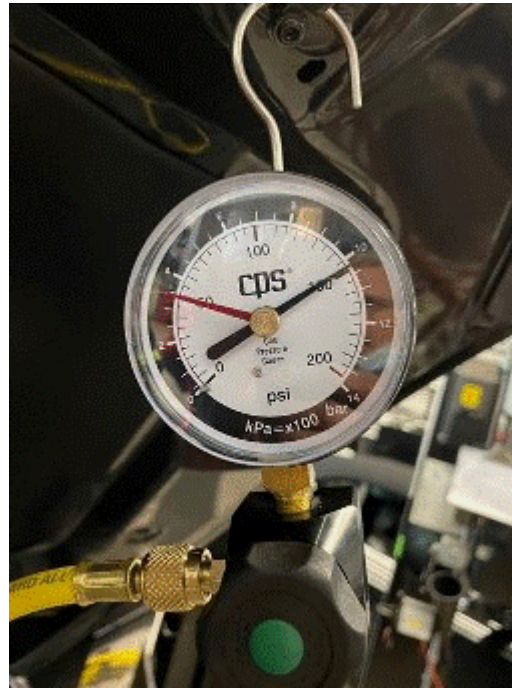
Figure 5. Calibration gas pressure in the circuit.

9. Connect the VAS 584005 Pressure Reducer to the NITROKITG manifold. Fill the circuit with calibration gas to an absolute pressure of no greater than 14 bar (Figure 5).

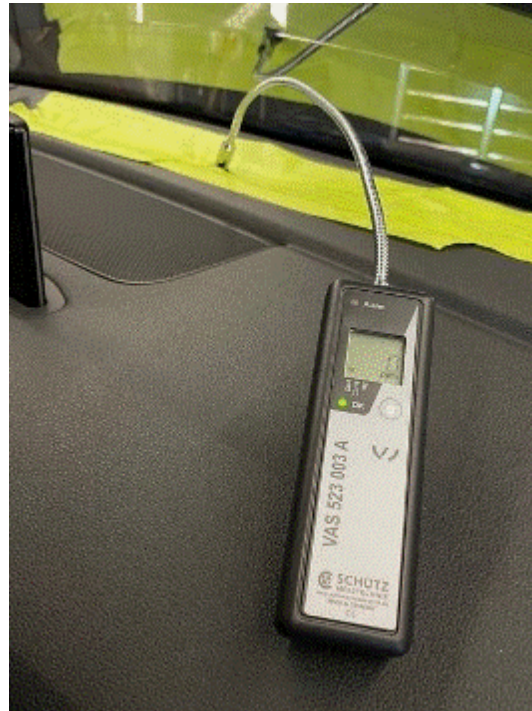
Figure 6. VAS 523003A gas leak detector in place in the defroster outlet.

11. Close off the defroster outlets with masking tape leaving a small opening for the VAS 523003A gas leak detector probe (Figure 6).

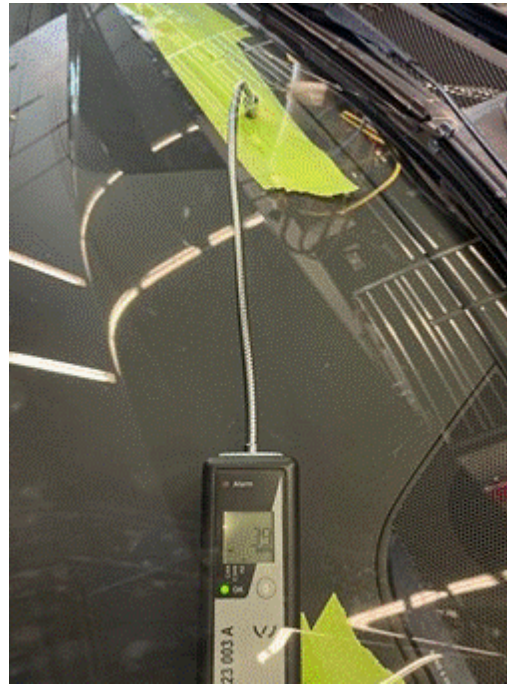
12. The gas leak detector VAS 523003A reacts to the hydrogen component in the calibration gas. Since hydrogen is lighter than air, it will rise to the position of the detector probe. The hydrogen content in the calibration gas, however, evaporates after a short period of time (Figure 7).

Figure 7. VAS 523003A in place in the defroster outlet and hydrogen presence is detected.

Perform the leak diagnosis immediately after charging the refrigerant circuit with calibration gas and the 20-minute equalization period. Depending on the conditions, it may be necessary to recharge the refrigerant circuit with calibration gas in an attempt to clearly identify a circuit leak at the evaporator core.

13. If no leak is detected through the defroster outlet using this method the evaporator core is not the source of the refrigerant leak and the evaporator core is not to be replaced. Continue diagnosis using the VAS 523003A along all remaining components of the refrigerant circuit to determine the source of the leak.
14. When any and all leak sources have been identified close the valve on the top of the calibration gas tank. Any calibration gas that remains in the refrigerant circuit can be slowly ventilated until the circuit pressure has equalized with atmospheric pressure. Proceed with the necessary repairs, evacuate the refrigerant circuit, and recharge the system as necessary.
15. When re-energizing a high voltage vehicle observe the following:
