Technical Service Bulletin

96 High beam assist or traffic sign detection limited, DTC C12B3FD may be stored in the DAS control module

96 22 77 2059201/5 April 14, 2022. Supersedes Technical Service Bulletin Group 96 number 21-63 dated March 12, 2021 for reasons listed below.

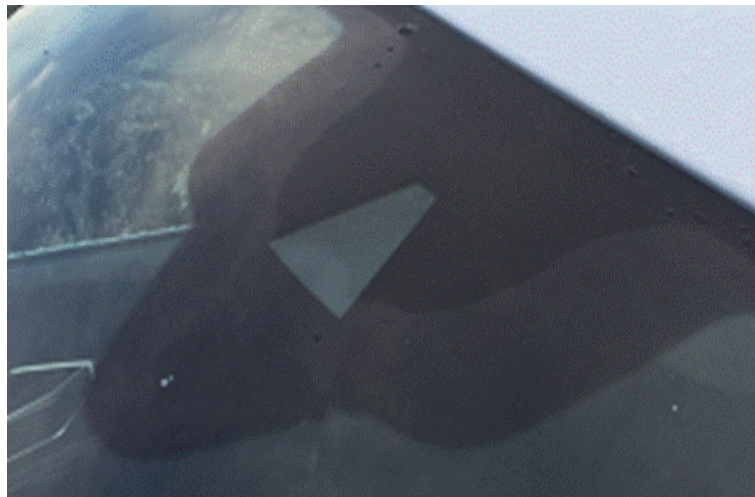
The viewing area of the front camera can be fogged up both on the inside and/or on the outside (Figures 1 - 2).

Figure 1. Viewing area fogged up from outside.

3. The customer cannot see this from the interior of the vehicle. Often it is enough to switch on the wiper system to fix the concern.

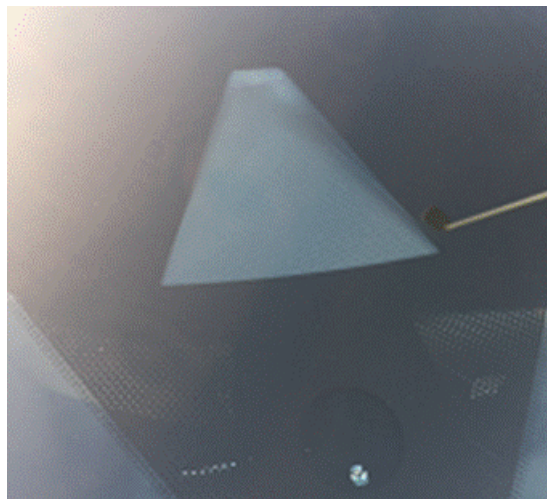
Figure 2. Viewing area fogged up from inside.

4. If the front camera is fogged up from the inside fairly often, it can help to remove its lens hood in order to clean and dry the viewing area of the camera.
