Technical Service Bulletin

40 Noises from front of the vehicle when driving - e-tron

40 22 39 2066882/1 April 26, 2022.

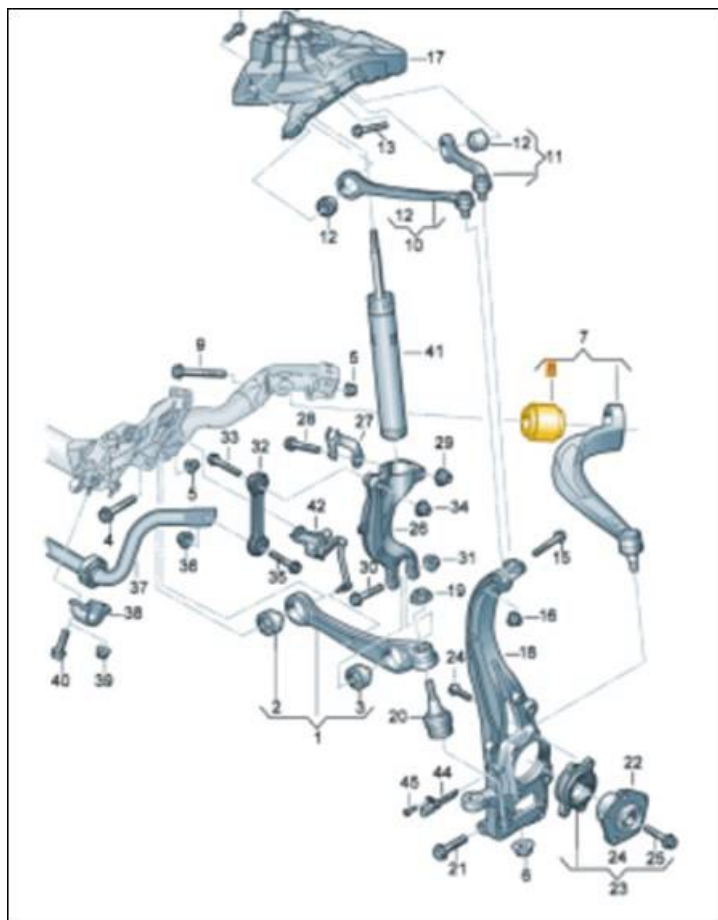
- Noises can be reproduced and are coming from:
 1. The guide link hydro bushing. Figure 1 (item 8, marked in yellow), or
 2. The drive train (electric motor, gearbox, driveshafts).

Figure 1: Guide link hydro bushing, front suspension.

The rattling/clacking noises made by the guide link hydro-bushing are caused by an air bubble that is enclosed inside the bushing during the manufacturing process. When vibrations are induced in the axle by an uneven road surface (multiple brief hard knocks in quick succession), the high-frequency change in the bushing's internal pressure causes the volume of the air bubble to change. This can produce rattling/clacking noises under certain temperature conditions.

- Replace the guide link bushing on both sides with guide link bushing part number described in the parts table below.
