Technical Service Bulletin

40 Rumbling/creaking noises from front of the vehicle when driving - Q7, Q8, A8

40 22 40 2058489/4 April 26, 2022. Supersedes Technical Service Bulletin Group 40 number 21-27 dated August 17, 2021, for reasons listed below.

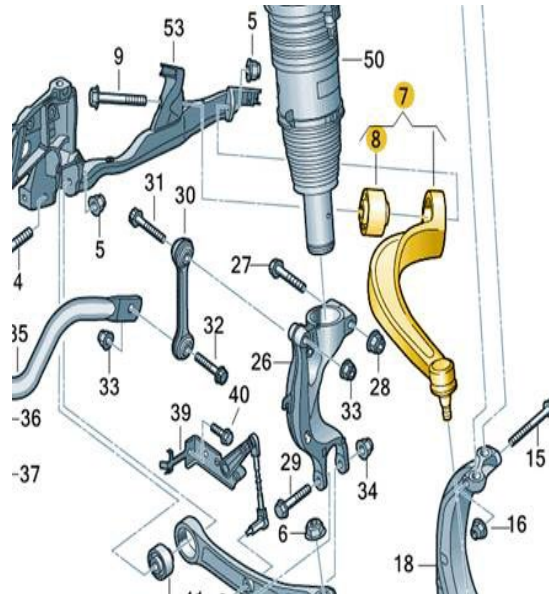
Figure 1. Hydro-bush.

The noises can be generated on the lower-left guide in the area of the hydro-bushing. (Figure 1, Positions 7 and 8).

The noises from the guide link can be transmitted into the vehicle interior by the connection of the subframe on the body and are noticeable in the footwell.

1. Replace the hydro-bushing on the guide link in pairs (Figure 1, Position 8) according to the instructions in Elsa at Repair Manual, *Chassis >> Suspension, Wheels, Steering >> 40 Front Axle >> Lower Control Arm and Ball Joint >> Guide link bonded rubber bushing, Removing and Installing.*

3. If repeat repairs are necessary and the hydro-bushing has already been replaced (pressed out/in), the complete guide link has to be replaced (Figure 1, Position 7) in Elsa at Repair Manual, *Chassis >> Suspension, Wheels, Steering >> 40 Front Axle >> Lower Control Arm and Ball Joint >> Guide Link, Removing and Installing.*

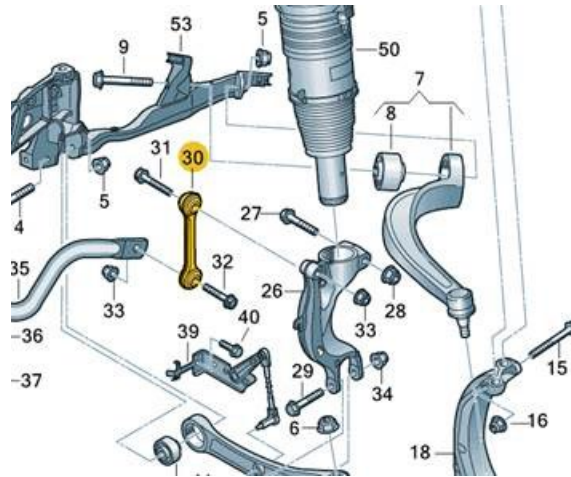
Figure 2. Coupling rod.

Parts such as the coupling rod (Figure 2, Position 30) are usually replaced by mistake, presenting no problems.
