Technical Service Bulletin

PSS 91 MIB3: lower display is flickering or distorted

91 22 96 2066224/2 April 25, 2022. Supersedes Technical Service Bulletin Group 91 number 22-81 dated February 23, 2022, for reasons listed below.

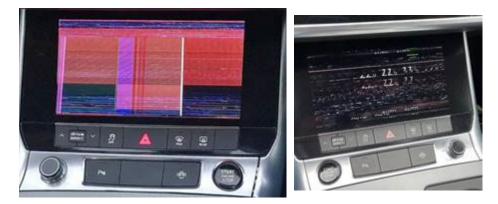
• The lower display flickers intermittently or the display seems to be distorted.

Figure 1: Display distorted

Figure 2: Display flickering

A software malfunction may cause the lower display to flicker or be distorted.

- Explain to the customer that a solution is expected by the end of the 4th quarter of 2022 (subject to change) and that no repairs are necessary at this point. Do not replace any components for this condition since this will not resolve the customer's concern.
- Create a PSS record in the PSS application through the Pending Service Solutions (PSS) link in AccessAudi (under *Related Links >> Service*), or through the Technical Assistance page in Elsa.

- 1. Reboot the MMI (refer to "Restarting the MMI" in the owner's manual)
 - a. Push and hold the volume/power button for at least ten seconds until you see the upper MMI screen boot back up.
