Service Bulletin

Bulletin No.: 22-NA-084

Subject: Information on Unable to Open Folding Top, DTC B19E1 sym64 Possibly Set

Brand:	Model:	Model Year:		VIN:		Engine:	Transmission:
		from	to	from	to		
Chevrolet	Corvette	2020	2022	-	—	All	All

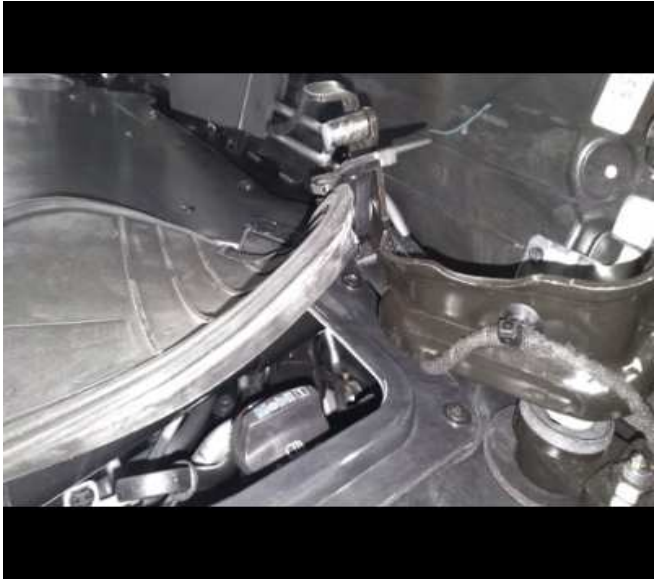
Involved Region or Country	North America, Europe, Middle East, Japan, Israel, Palestine Thailand, Australia/New Zealand
Condition	Some customers may comment that the folding top will not open. Technicians may find DTC B19E1 sym64 set.
Cause	<div style="text-align: right; margin-bottom: 5px;">6039905</div>

<p>The cause of the condition may be that the body side frame access hole plug may not have been seated properly. This may lead to the plug interfering with B373 Folding Top Side Rail - Roof Panels Stowed Sensor.</p> <p>Note: The body side frame access hole plug must be fully seated whenever the plug is removed.</p>
Correction	<ol style="list-style-type: none"> 1. First gain access to the body side frame access hole plug. Refer to <i>Opening the Folding Top Stowage Compartment Lid — Engine Access</i> section within <i>Folding Top and Folding Top Stowage Compartment Lid Operation</i> in the Service Manual. 2. Inspect the body side frame access hole plug to assure it is fully seated. <p>Note: The customer should be informed to ensure the access plug is secured, and fully seated, before driving the vehicle whenever the oil or coolant is checked. Please share this information with the customer, including a copy of this bulletin.</p>
