# Technical Service Bulletin

## 35 Gearbox malfunction message in cluster (DTCs P17D800, P179D00, P174000, P174C, P174B, P174F, P179C, P174A, P174E)

35 13 13 2030477/4 July 12, 2013. Supersedes Technical Service Bulletin Group 35 number 13-10 dated May 7, 2013 for reasons listed below.

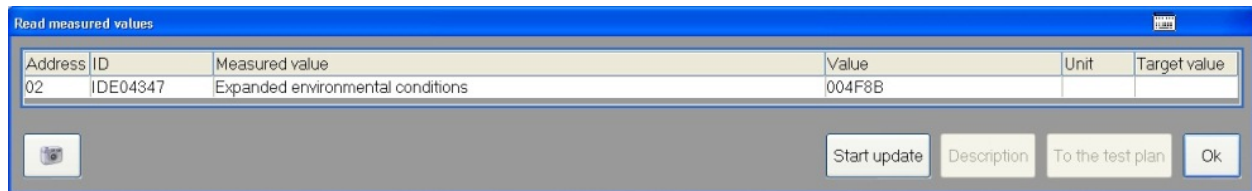
**Figure 4.** Example of “Expanded environmental conditions”. In this example, the last four digits do not match the codes listed in the *Condition* section, so this TSB would not apply.
