Y1A Connection Oxidation Causes SOS Warning or Missing Surround View Images

Models	Model Year	Model Type	VIN Range
Taycan	2020 - 2022	Y1A	n/a

Revision	Release Date	Changes
0	April 6, 2022	Initial release

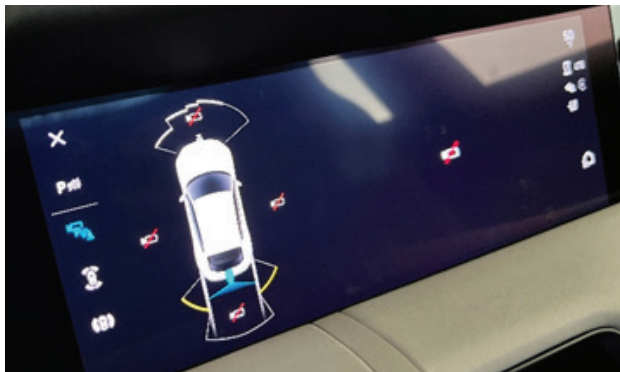
Figure 1

The customer may observe either an SOS warning in the instrument cluster or one or more missing surround view camera images in the PCM. (See figure 1.)

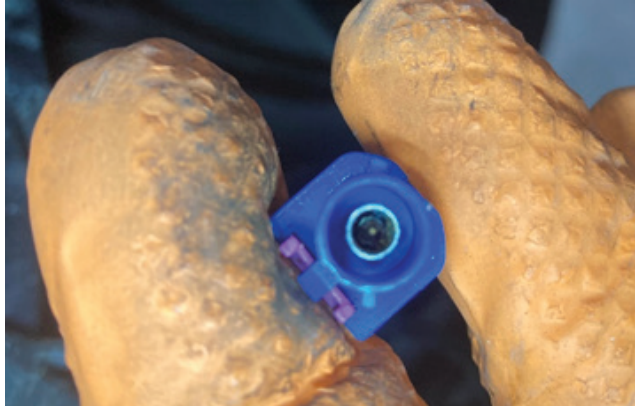
Figure 2

The root cause for this issue is oxidation on the wheel housing connection point. Technicians may find evidence of water intrusion on the connector or in the area. (See figure 2.)

1. Examine the connection between the LTE antenna 3 and the antenna cable in the front bumper.
2. If you find evidence of corrosion or water intrusion on the connector or water damage in the wiring, exchange the front wiring harness, repair the main wiring harness with VAS 6720, and seal the connector with Butyl tape.
3. See TI 149/21 for information on replacing the camera itself, only if this is necessary.
