992-Upper Oil Pan Seal Housing Leak

Models	Model Year	Model Type	VIN Range	Vehicle-Specific Equipment
911	Up to 2021	992	N/A	N/A

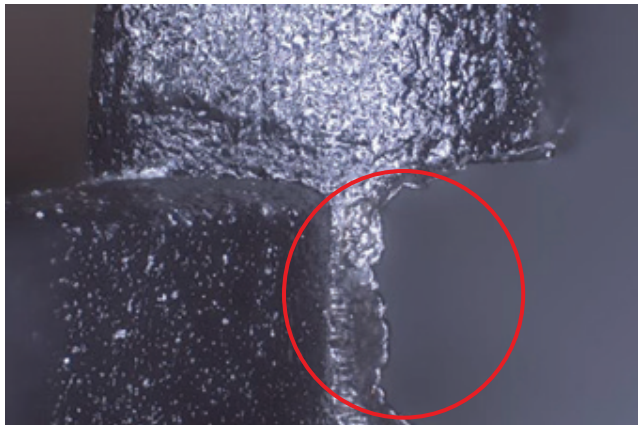
The aforementioned condition may be caused by an injection molding byproduct known as **flashing** which may be responsible for sharp edges in the upper oil pan housing as seen in **Figure 1**.

Figure 1 - Sharp Edges on Upper Oil Pan

Please replace the affected seal (**Part # OPB 115 111 B**) in case any oil leak coming from the rear (engine area) of the vehicle. Before replacing, please remove the plastic body of the new seal and check for the conditions described above. If flashing can be seen on the plastic body, remove it with an appropriate tool and check the seal for damage. If the seal is undamaged, reassemble the plastic body and seal correctly.

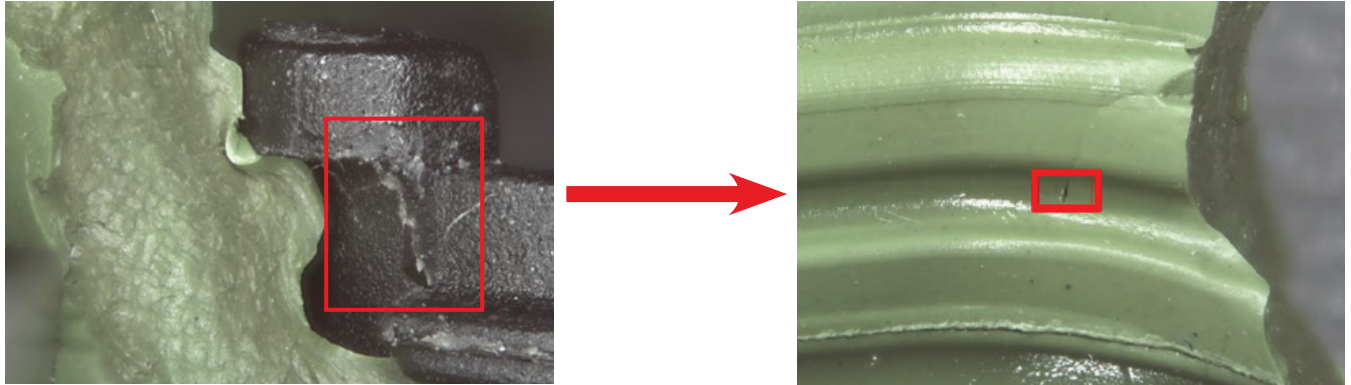
These sharp edges can potentially cause cuts to seals within the oil pan, and cause improper sealing of oil passages. Oil leaks can result from this in the above mentioned conditions. **Figure 2** below shows the damage on the seals caused by the sharp edges pictured in **Figure 1**.

Figure 2 - Effect of Injection Molding Byproduct Causing Damage in Seal
