Service Bulletin

Bulletin No.: 18-NA-102

Subject: Multiple Electrical Concerns, Intermittent Multiple Instrument Panel Cluster (IPC) Warning Lamps Illuminated, Intermittent Multiple Message on Drivers Information Center (DIC), Intermittent and/or Inoperative Loss of Interior and Exterior Lighting, Engine Performance Concerns, Stalling, Transmission Shift Performance Concerns, Malfunction Indicator Lamp (MIL) Illuminated

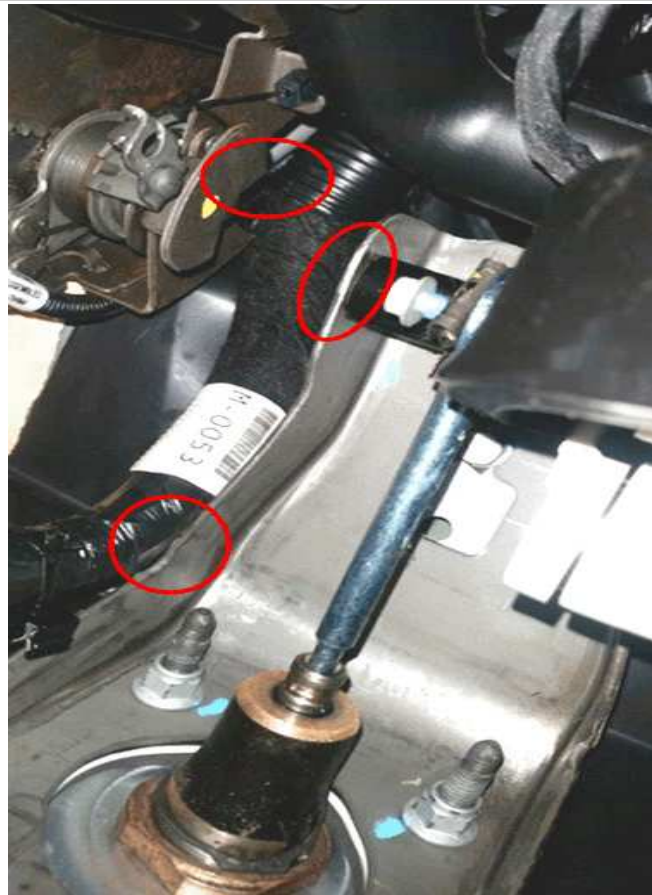
5031150

This condition may be caused by the main Instrument Panel (IP) wiring harness contacting one or more of the following:

- Brake booster mounting bracket

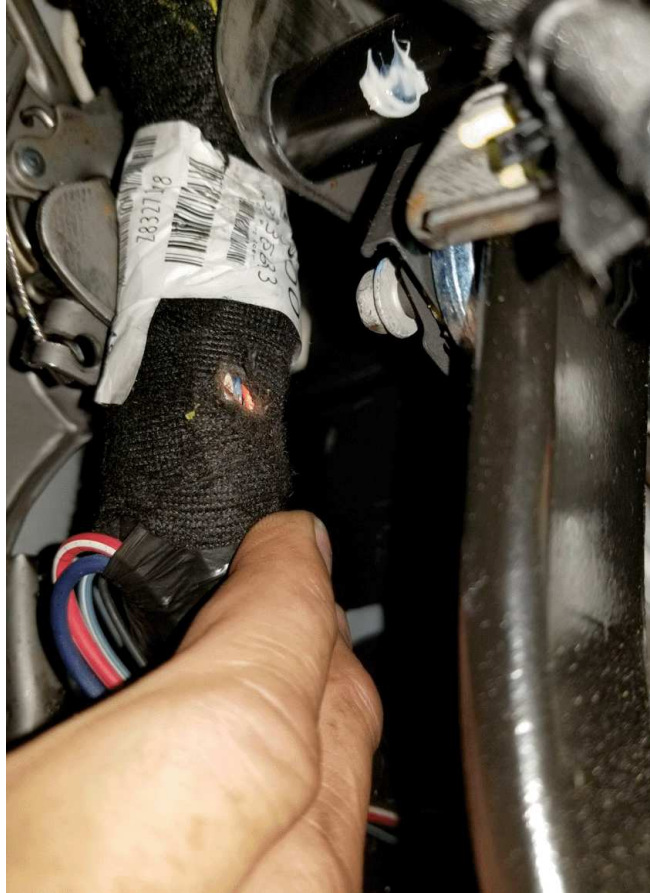
5035298

- Brake pedal pivot bolt

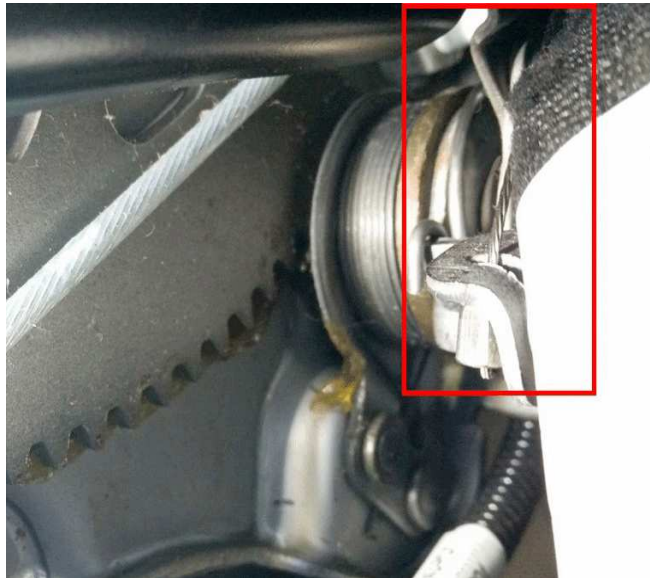
5035707

- Parking brake mechanism.
