SERVICE BULLETIN

APPLICABILITY: 2020-22MY Legacy and Outback Models **NUMBER:** 15-261-20R
SUBJECT: Reprogramming File Availability for Optimization of Gen 4 Denso CP1 Infotainment Systems **DATE:** 03/10/20
REVISED: 04/22/22

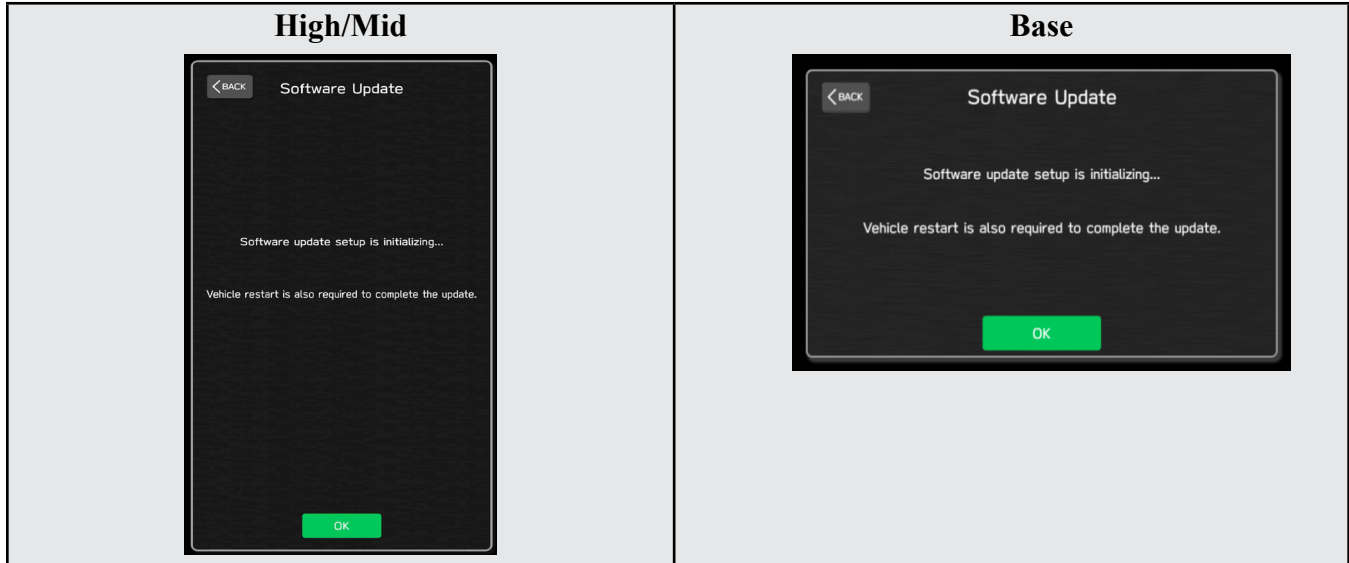
- If the screen shown below appears, **WAIT** for approximately 30 minutes or as long as necessary (waiting for longer than 60 minutes might indicate system malfunction). In that case please perform recovery according to the instructions in “Appendix B ” to allow the Software update setup initialization process to complete.

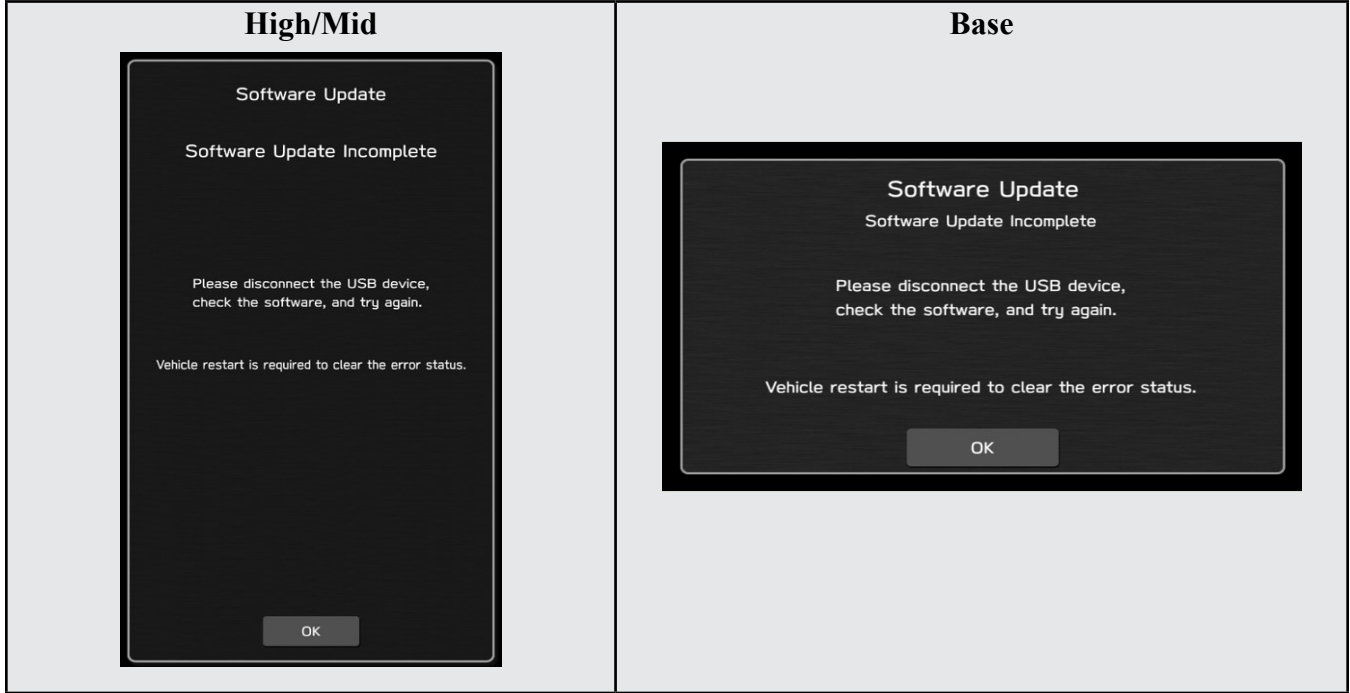
- If the first attempt of update fails with the message below, follow the steps described below 1-2 to 1-8 before retrying the software update.

1-1. Select OK in the screen below

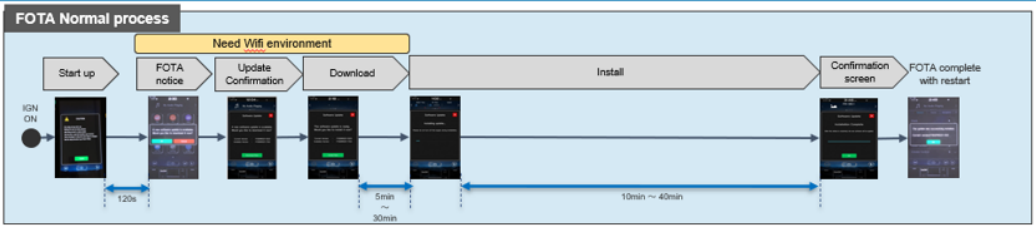
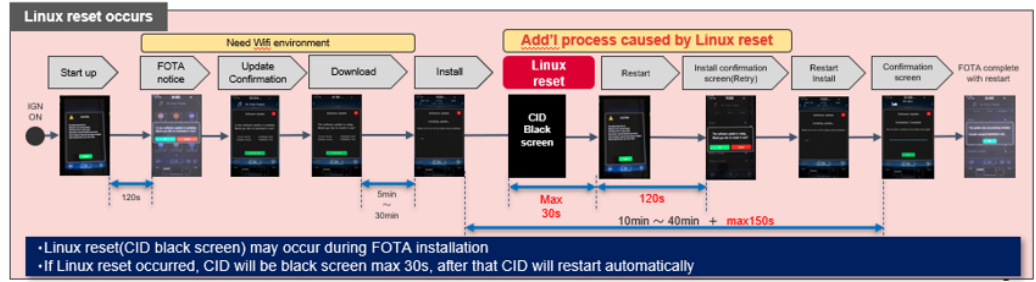
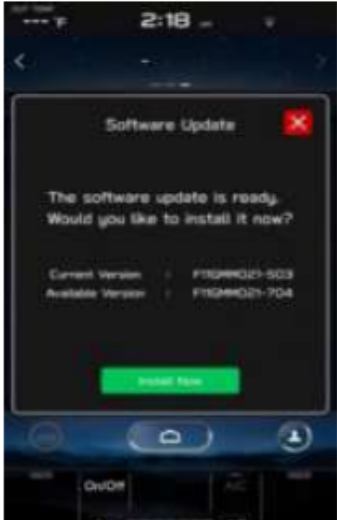
Number	Symptoms to be Improved:
1	<p>System restarts itself during FOTA (Firmware Over The Air) update. FOTA operation is conducted in two processes: downloading (from the server to the Cockpit Control Unit via Wi-Fi) and installation (inside the Cockpit Control Unit). During the FOTA operation, after the new software has been downloaded to the Cockpit Control Unit (CCU) customer is to push “Install Now” on the Center Information Display (CID) to start installation of the software.</p>

<p>However, in rare case, the CCU restarts itself* during installation.</p>

<p>Note* Even if this symptom occurs, after approximately 2 minutes, the system resumes, and the CID comes back to the below screen. Customer can then push the “Install Now” to proceed with the installation.</p>
