Service Bulletin

Bulletin No.: 22-NA-057

Subject: Fuel Door Does Not Open, Fuel Door Tappet Falls Out of the Hinge

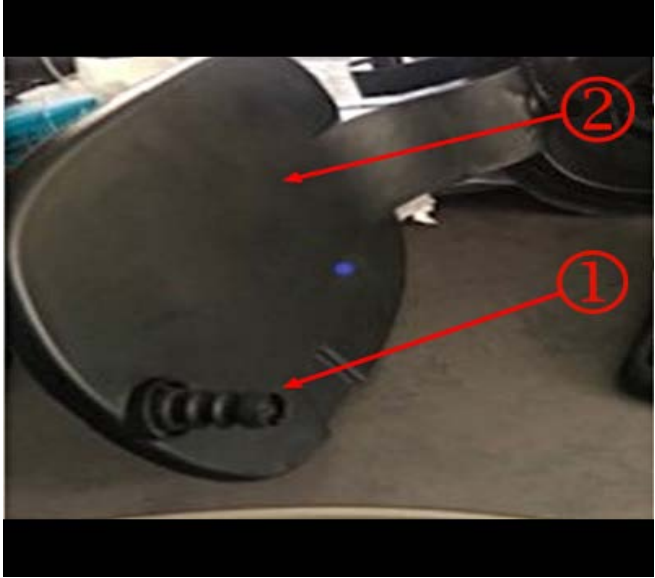
<p>This condition may be caused by the tappet, as shown in the picture above (tappet and rubber boot) (1), becomes detached making the tappet loose in the housing hinge (2) misaligning the tappet to the lock actuator or the tappet is no longer retained to the hinge (missing tappet). The misalignment of the tappet to the lock actuator could cause the fuel door to not operate correctly and in some cases damage the lock actuator or lock actuator mount (3), shown in the picture above. A missing tappet boot may also cause the tappet to become detached to the hinge as the boot is part of the secure attachment of the tappet to the hinge.</p>

<p>Correction</p>	<p>If the tappet or boot is missing, replace the tappet following the procedure below. Note: Replace the fuel door if it is damaged, new fuel door comes with the tappet.</p>

1. Remove the tappet, turn clockwise ¼ turn and discard.
2. Align the new tappet base tabs to the hinge opening and turn counter clockwise ¼ turn, making sure the tappet boot is correctly positioned and

Note: The new tappet should NOT have any movement in any direction.
