<b>Subject:</b>  <b>CONNECTED VEHICLE SYMPTOM TROUBLESHOOTING</b>	<b>Service Alert No.: SA-017/22</b>
	<b>Last Issued : 04/04/2022</b>

## APPLICABLE MODEL(S)/VINS

2019-2022 Mazda3	2021-2022 CX-5	2022 MX-30
2020-2022 CX-30	2021-2022 CX-9	2023 CX-50

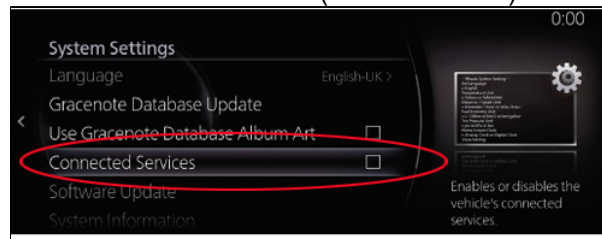
Connected Services Disabled message  
appears at engine start up

Connected Services disabled (box unchecked)

Enable Connected Services (box checked) to prevent  
message appearing at engine start up.

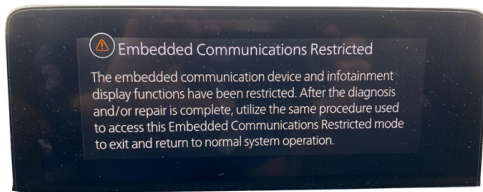
Connected Vehicle Maintenance Mode enabled.  
Go to MGSS SERVICE CAUTIONS FOR VEHICLES  
WITH TELEMATICS COMMUNICATION SYSTEM to  
disable Maintenance Mode.

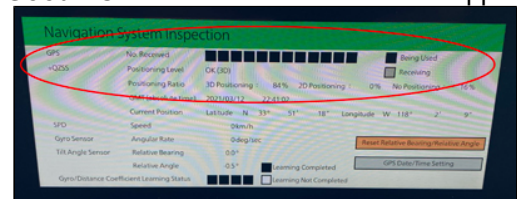
**Good** - Contact Hotline for technical support

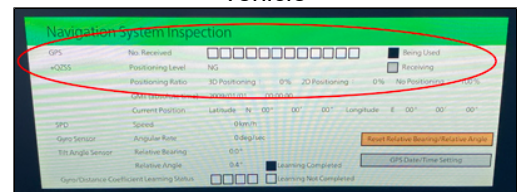
**No Good** - Swap Tel antenna No. 1 with known good vehicle
